**FINAL PROJECT REPORT FOR CLEAN-UP AND
REMEDIATION**

24" Nkpoku Bomu Pipeline impacted area

BERA GOKANA

**INCIDENT NOS: 970940 & 950208 INCIDENT DATE: 27/03/2013 CONTRACT
START DATE: 10/04/2013 CONTRACT END DATE: 18/07/2013 PURCHASE ORDER
NO: 4510295312 CONTRACTOR: GIOLEE GLOBAL RESOURCES NIG. LTD., and the
OSEI Corporation
WORK COMPLETION CERTIFICATION**

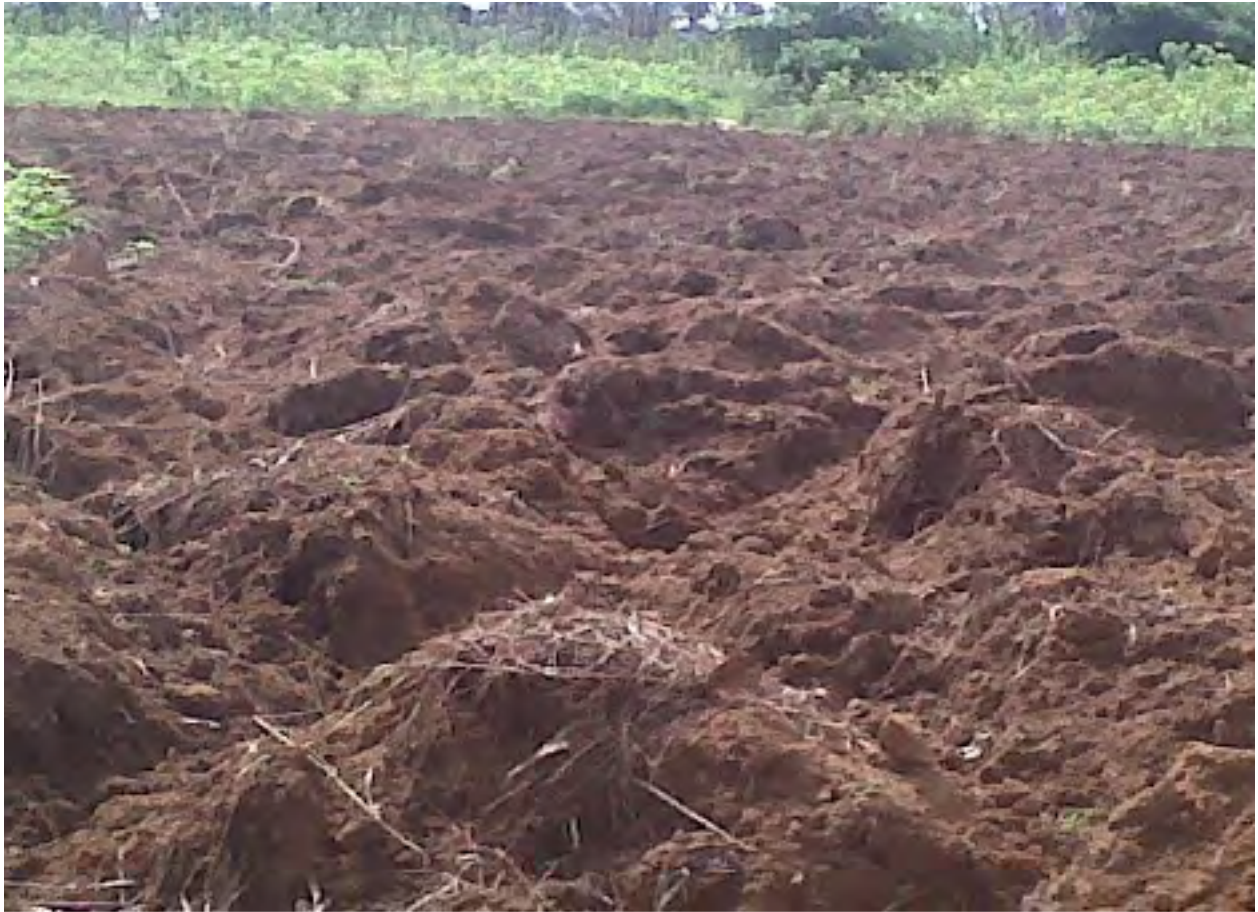
Initial Site after tilling

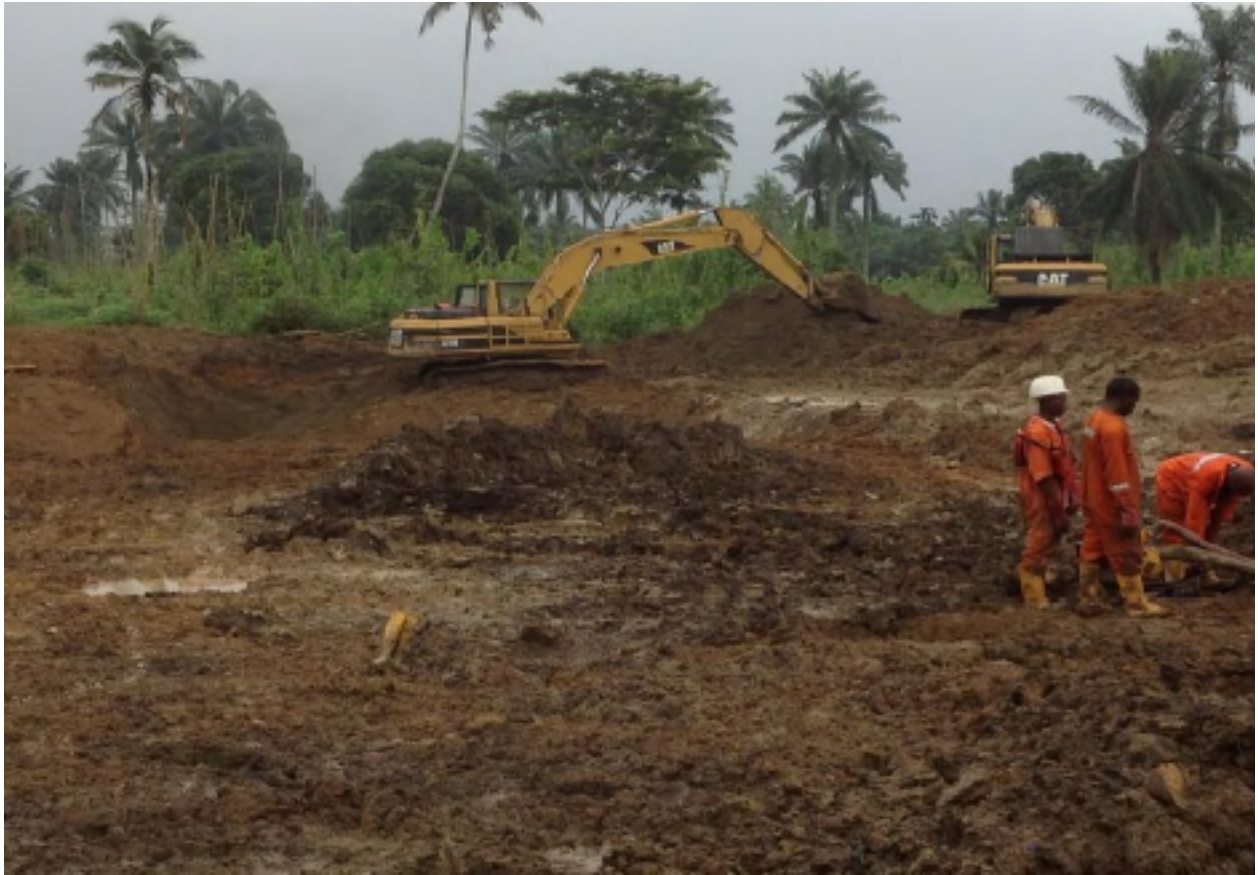
EXCAVATION IN PROGRESS AND GIOLEE STAFF WORKING

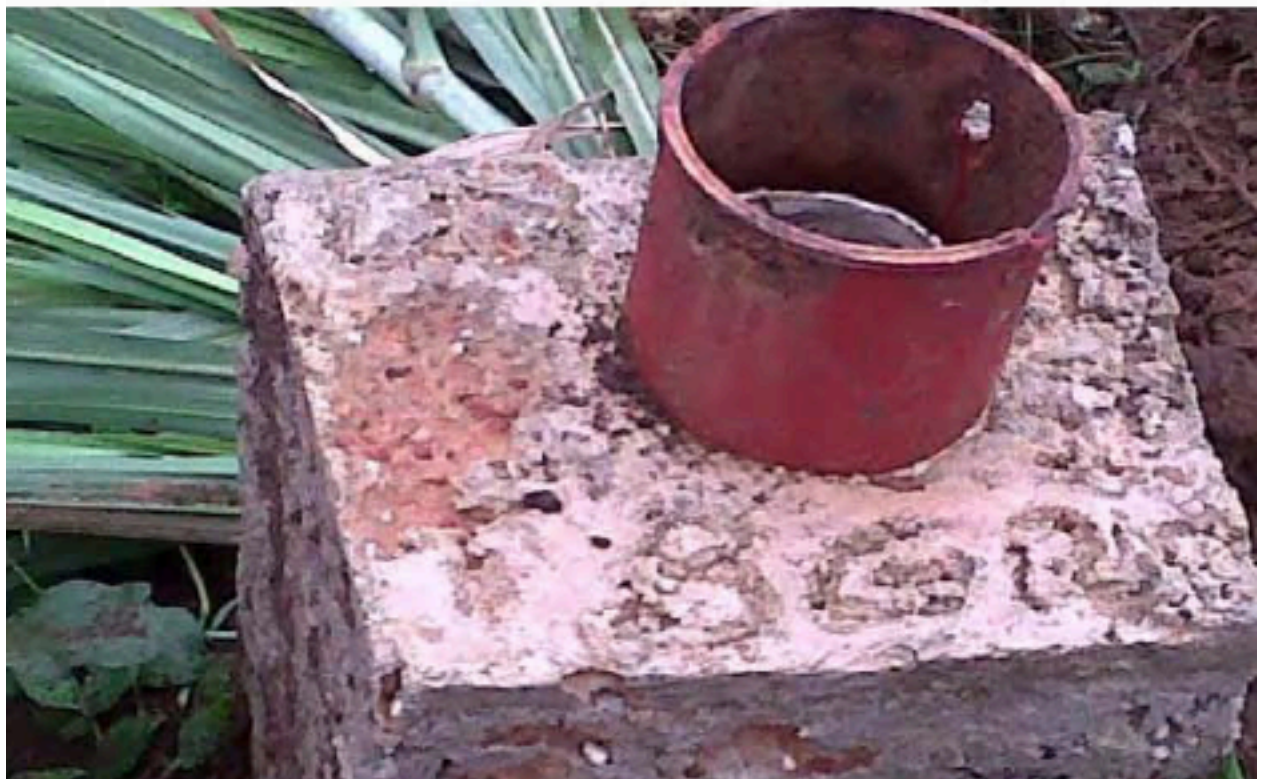
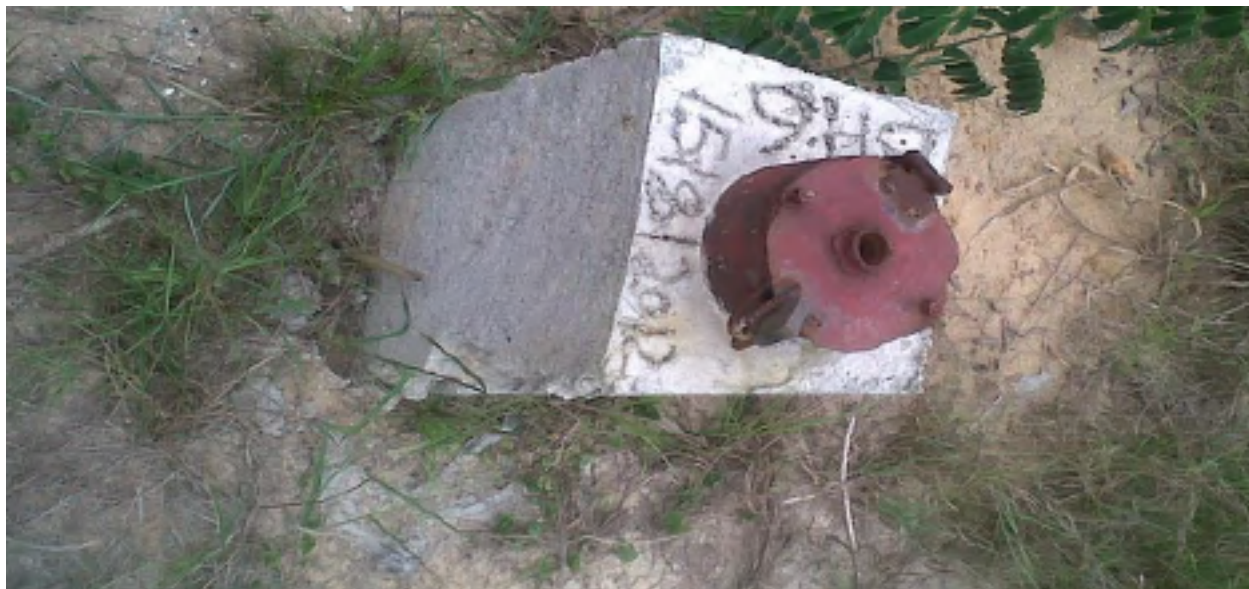
DIFFERENT BOLEHOLE POINTS THAT WAS EXCAVATED TO KNOW THE DEPTH AND LEVEL OF CONTAMINATION, BOLEHOLE 1, 3, AND 6

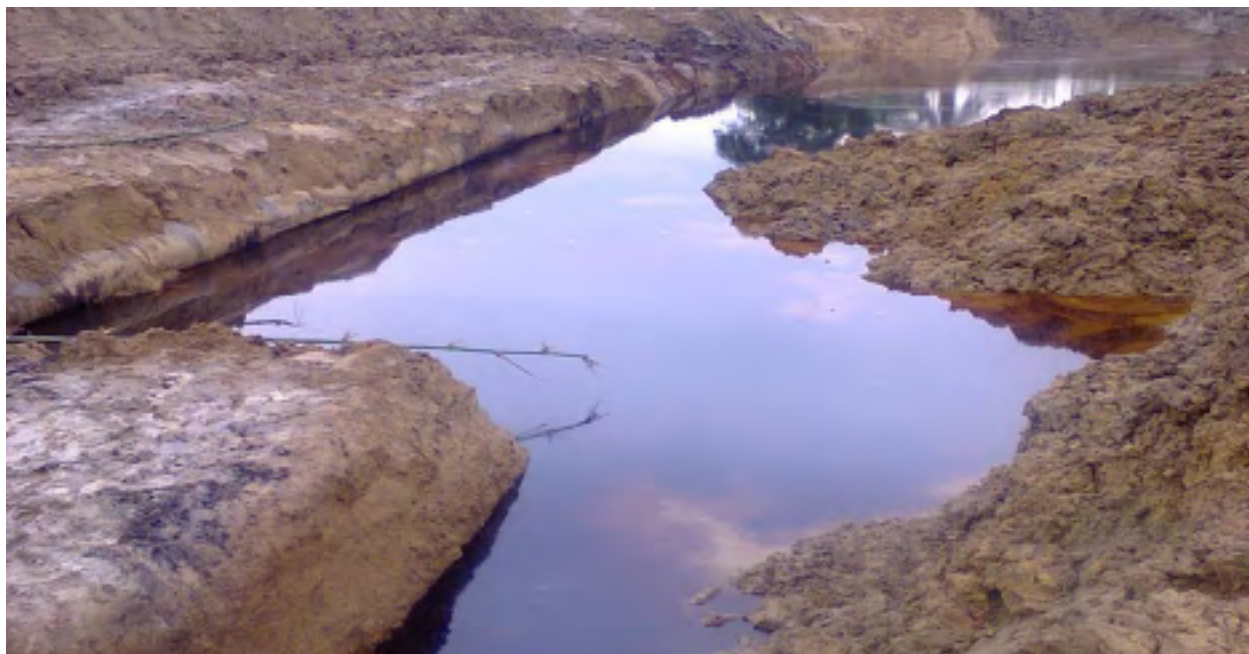
PIT1:EXCAVATED GROUND WATER TRENCH WITH CRUDE BEFORE RECOVERY AND APPLICATION OF OSE II

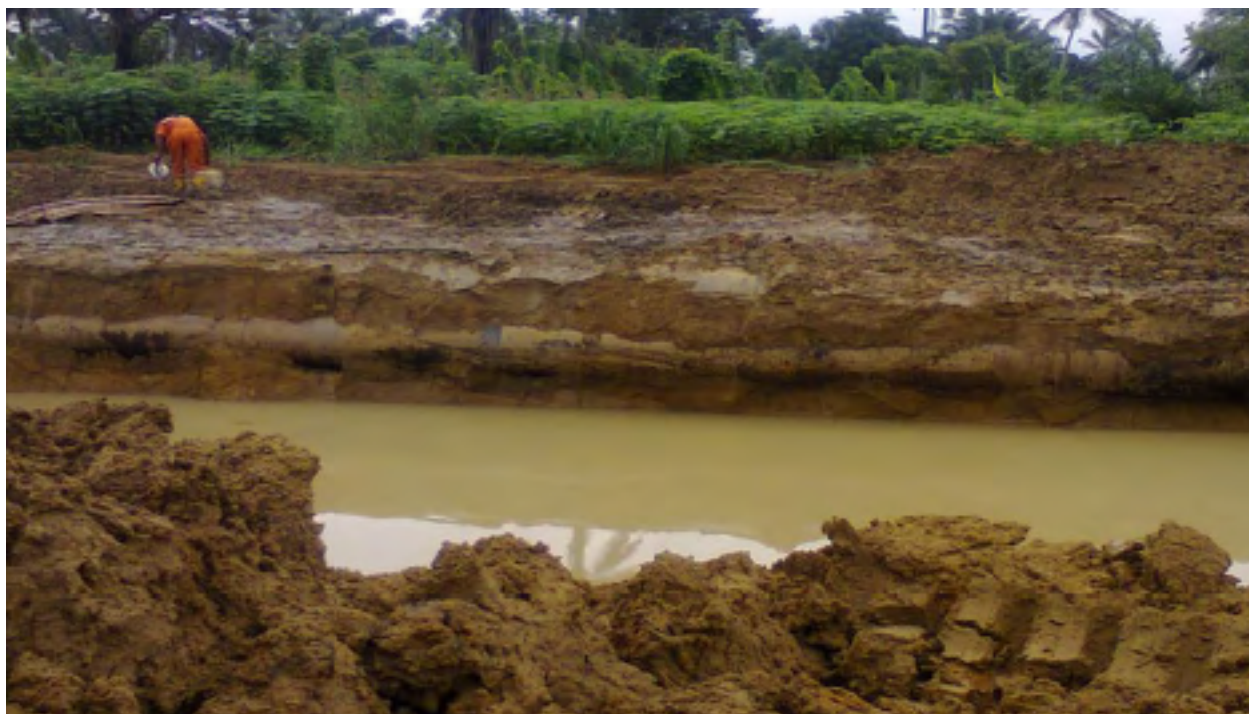
PIT1:EXCAVATED GROUND WATER TRENCH AFTER APPLICATION OF OSE II

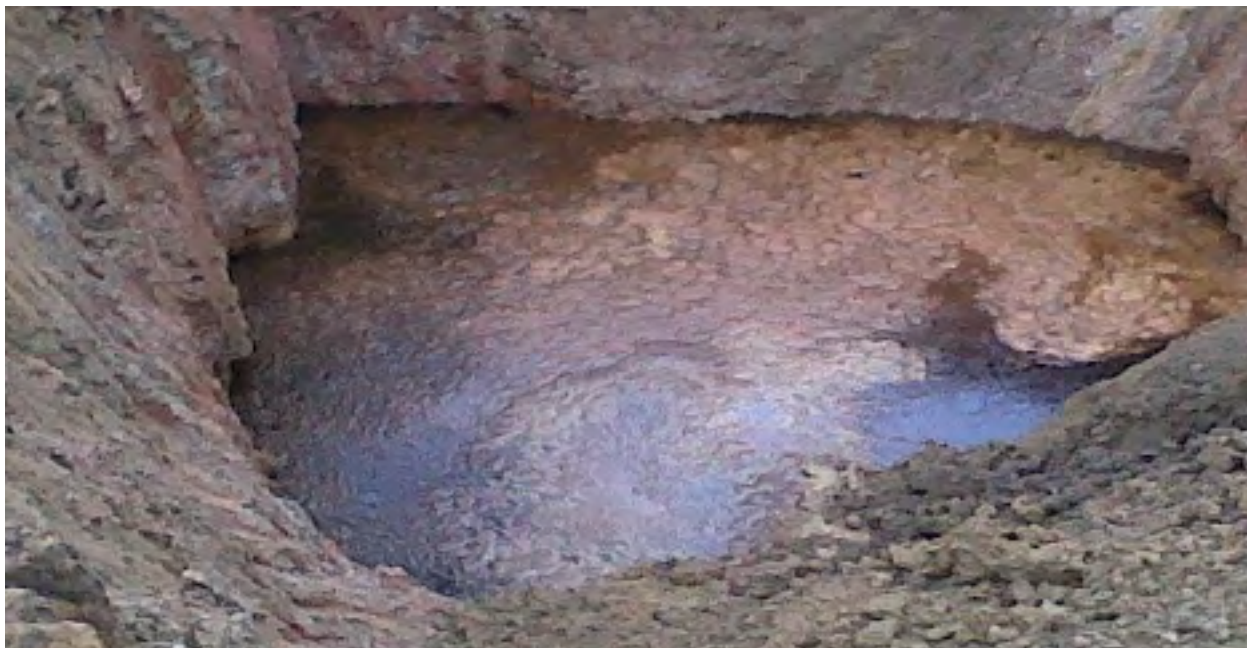
PIT2: INITIAL PIT STATE BEFORE THE APPLICATION OF OIL SPILL EATER II

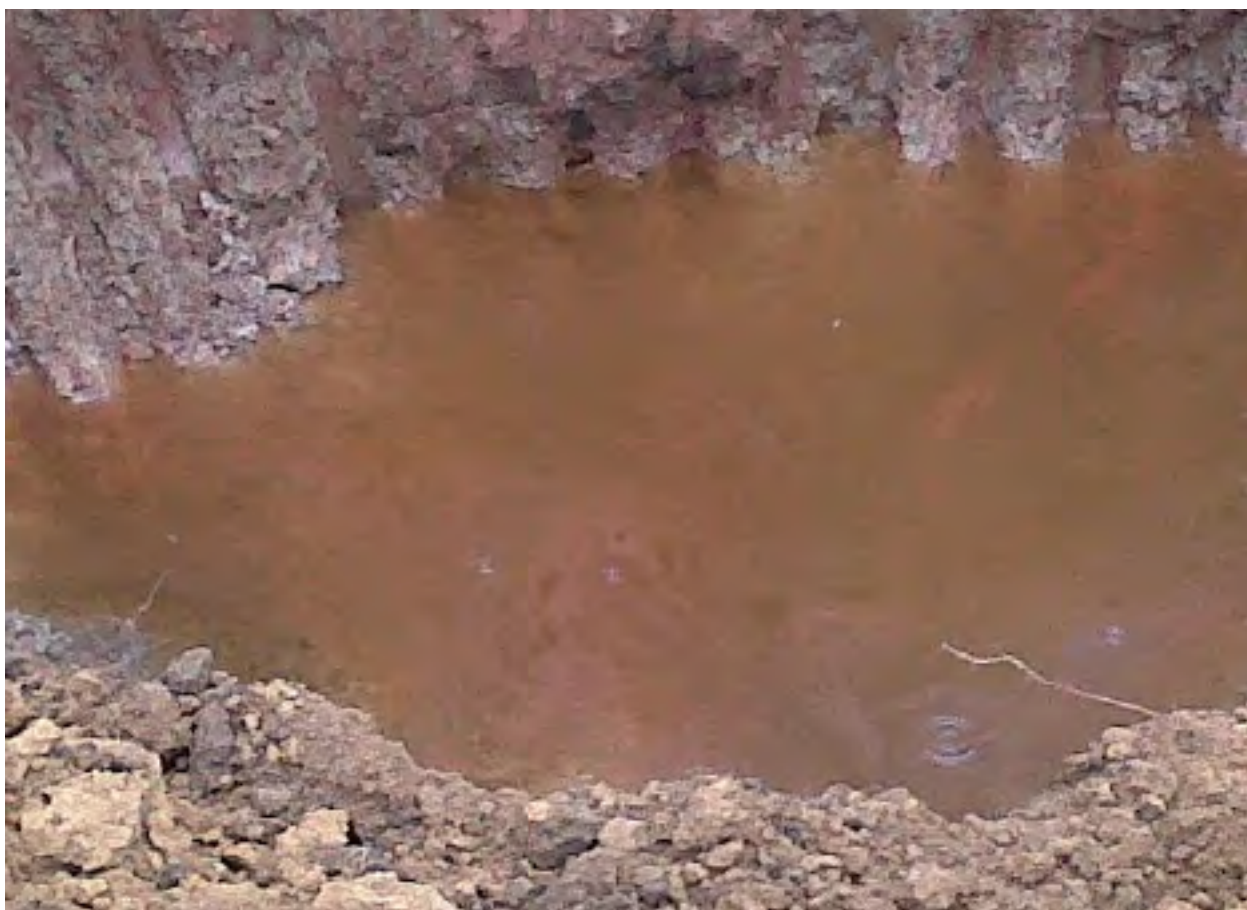
PIT2: AFTER APPLICATION OF OIL SPILL EATER II (OSE II)

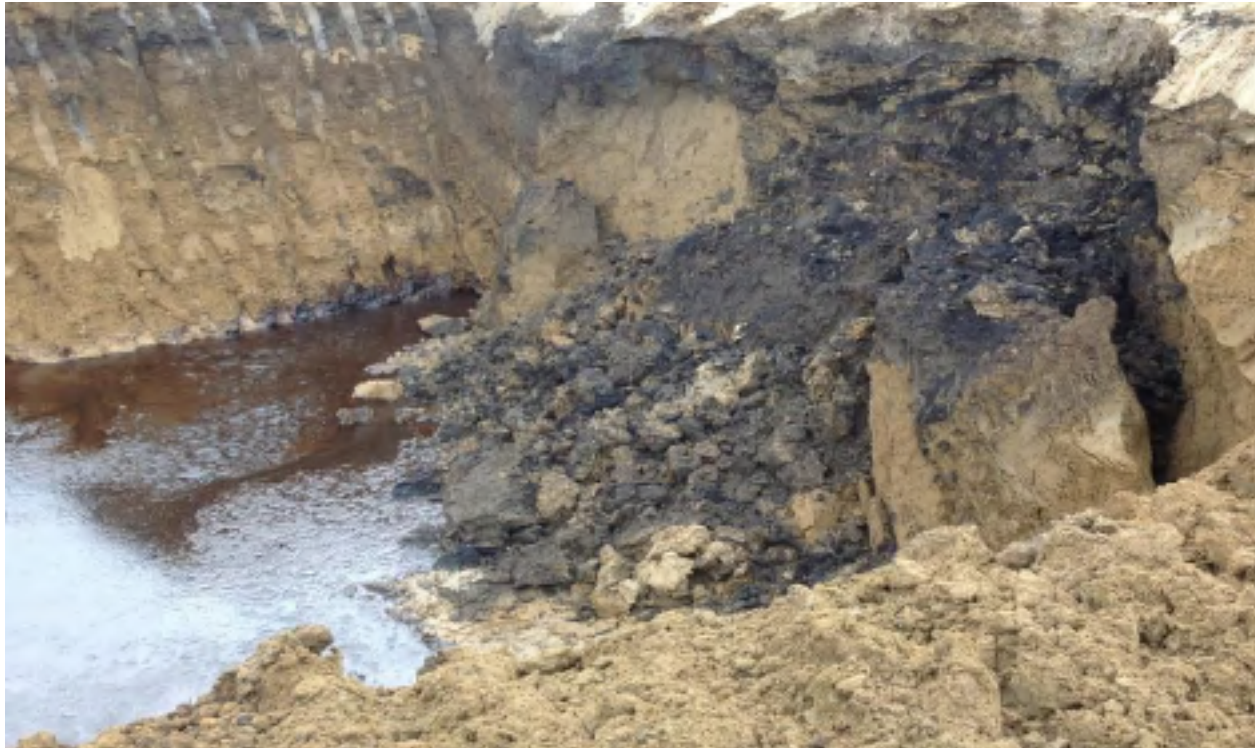
PIT3: BEFORE RECOVERY AND TREATMENT OF GROUND WATER WITH OSE

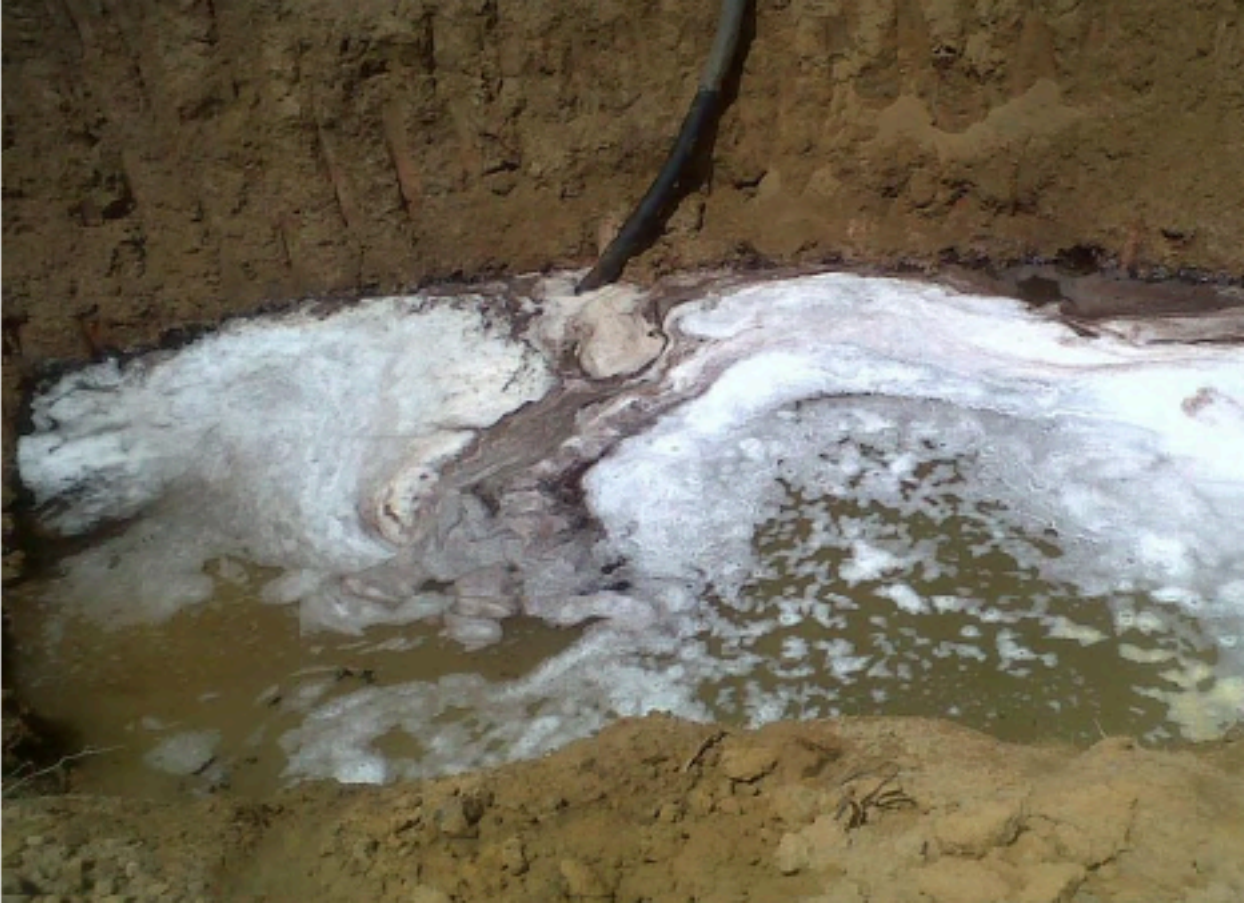
PIT 3: DURING APPLICATION OF OIL SPILL EATER II

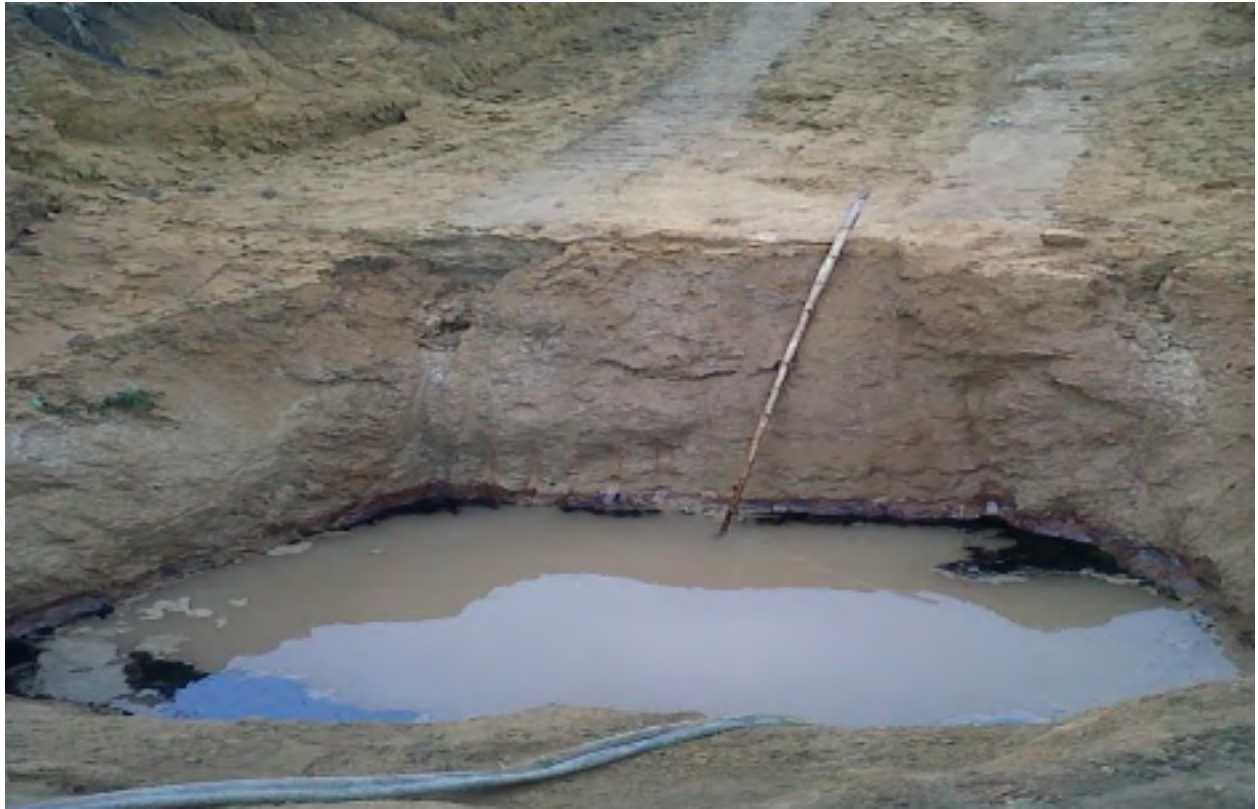
PIT3: IMMEDIATE REACTION AFTER RECOVERY AND APPLICATION OF OSE

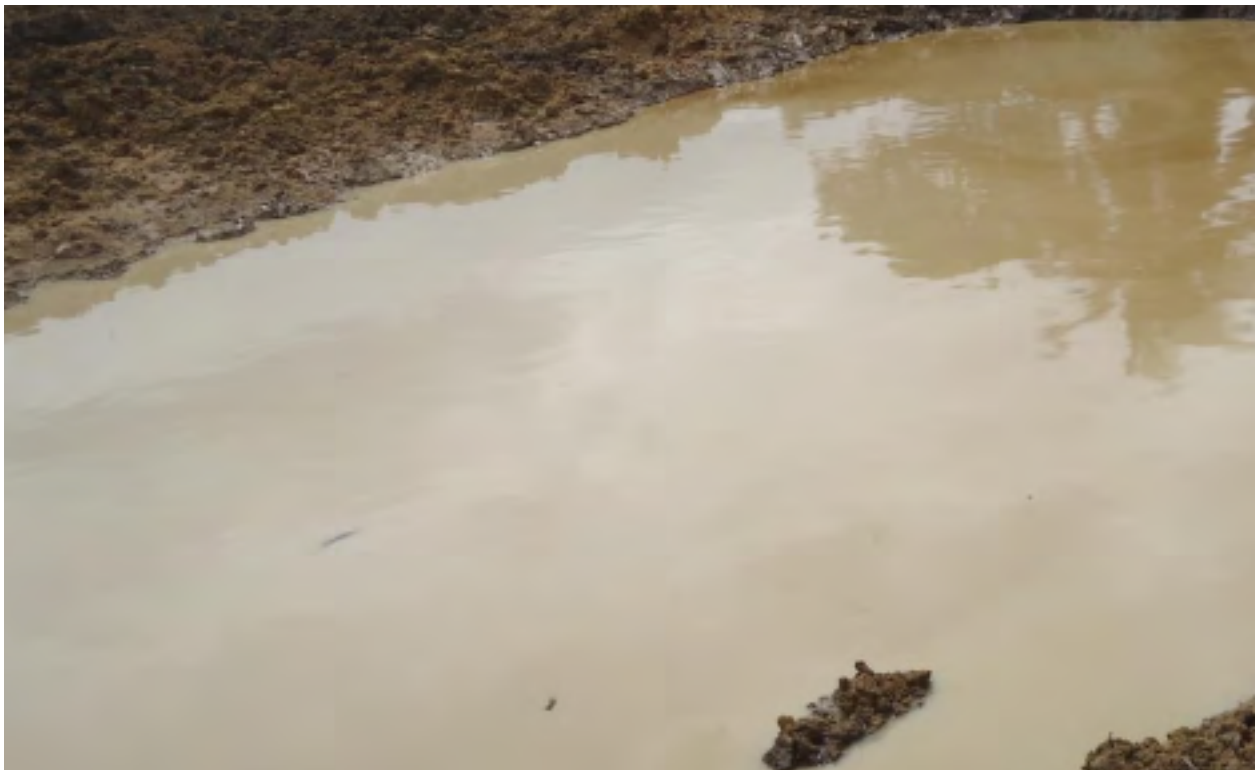
PIT4: BEFORE APPLICATION OF TREATMENT WITH OIL SPILL EATER II

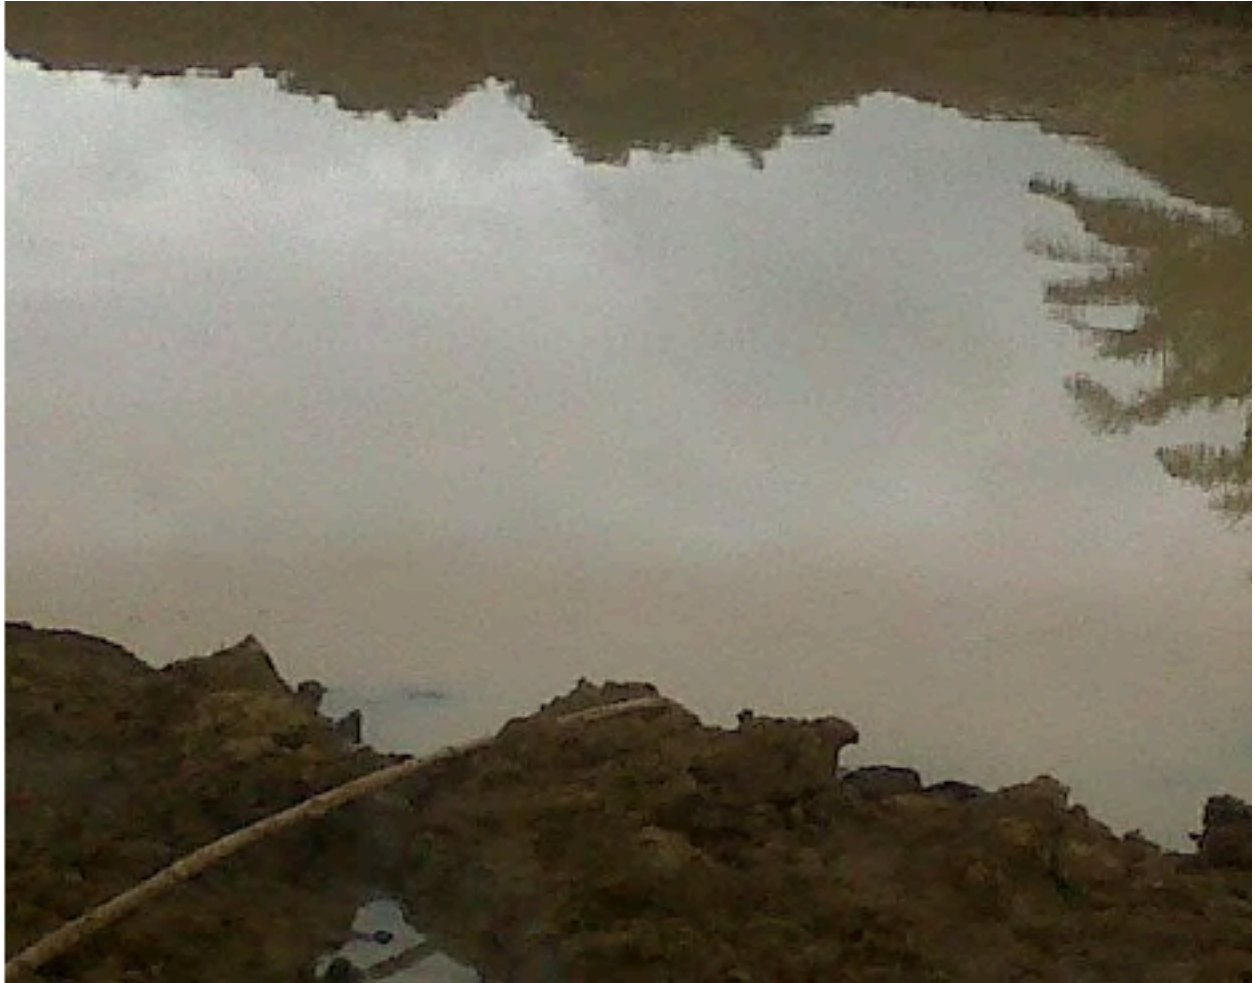
PIT4: AFTER APPLICATION OF TREATMENT

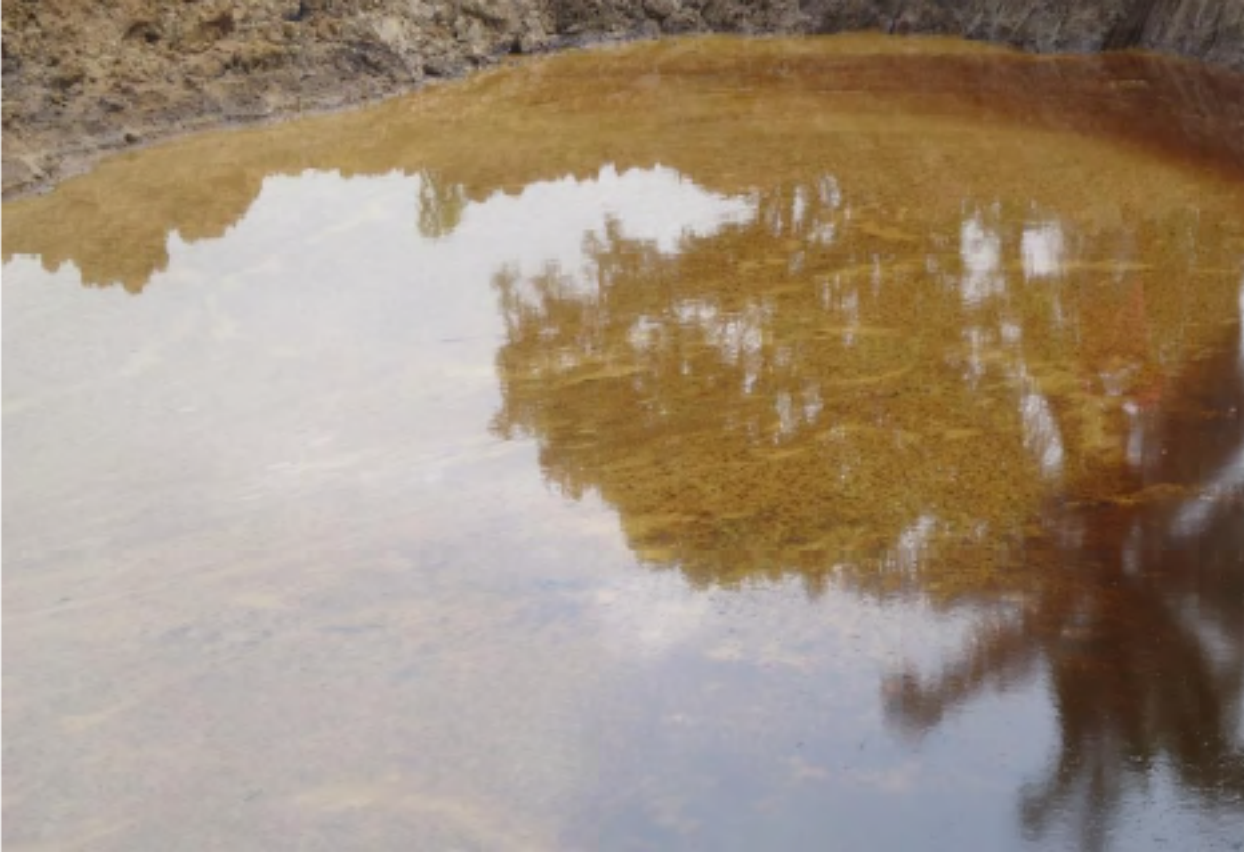
PIT5: BEFORE RECOVERY AND TREATMENT OF GROUND WATER

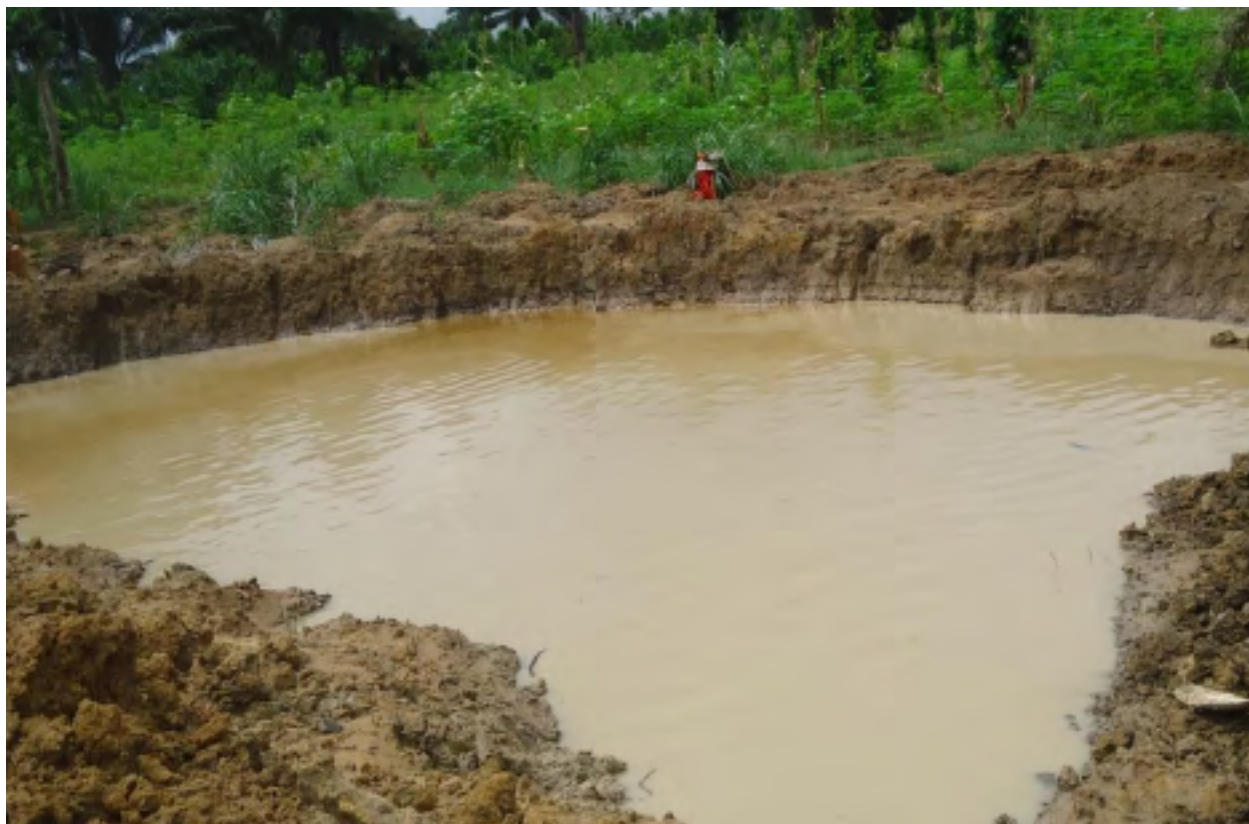
PIT5: A DAY AFTER APPLICATION OF OIL SPILL EATER II (OSEII)

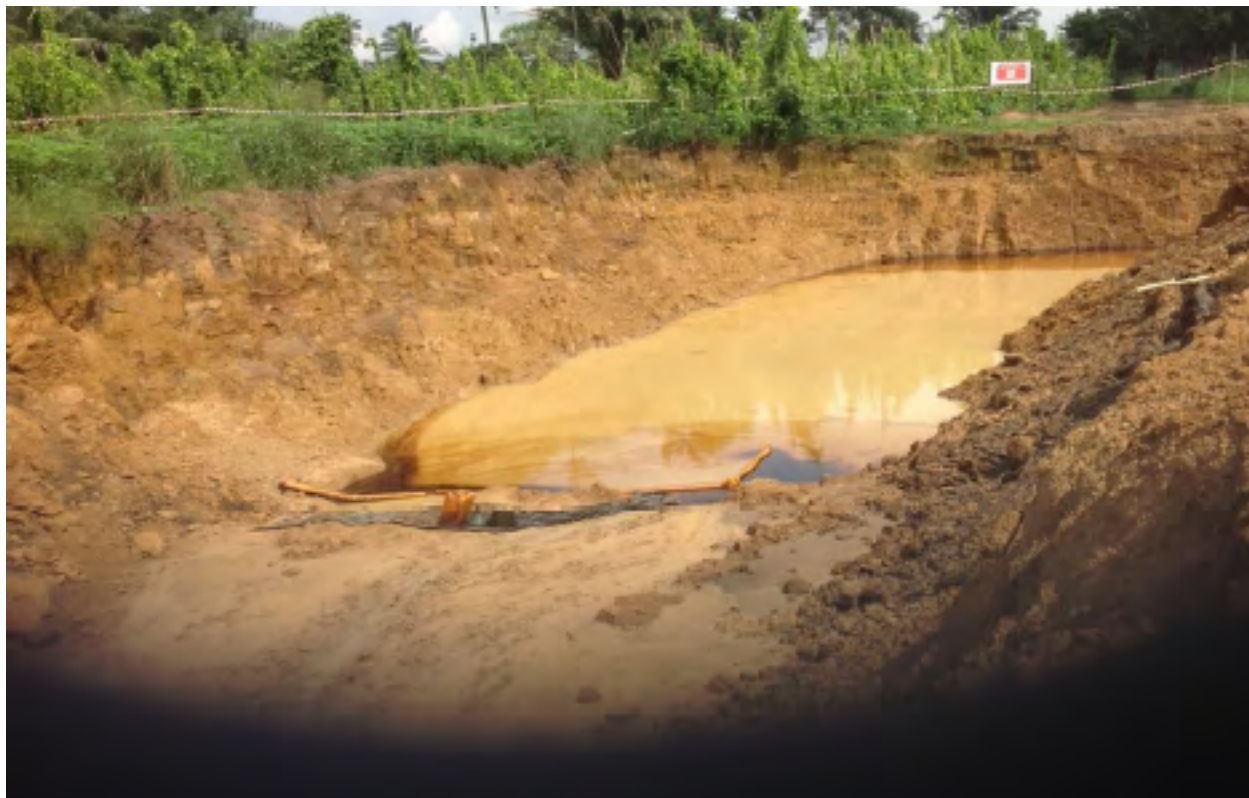
PIT6: EXCAVATED TRENCH OF GROUND WATER CONTAMINATED WITH HYDROCARBON

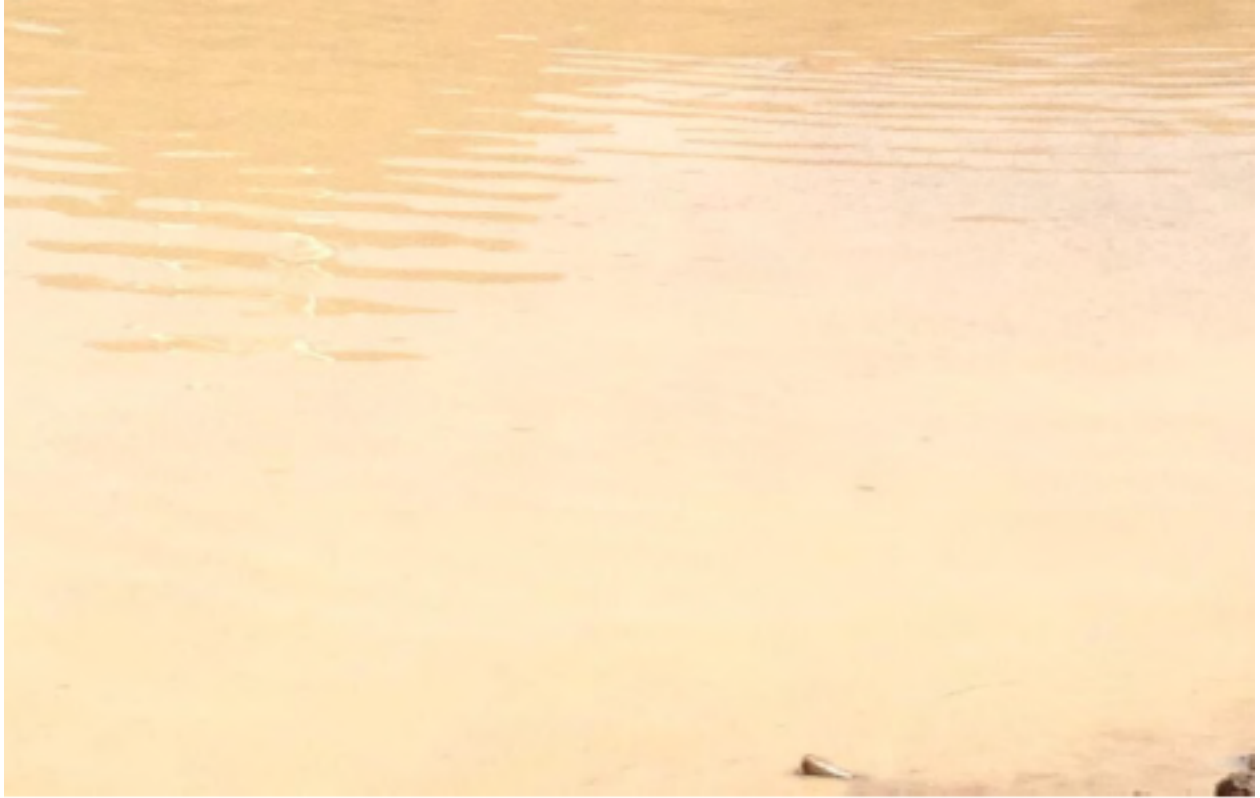
PIT6: TREATED EXCAVATED TRENCH OF HYDROCARBON CONTAMINANT WITH OIL SPILL EATER II

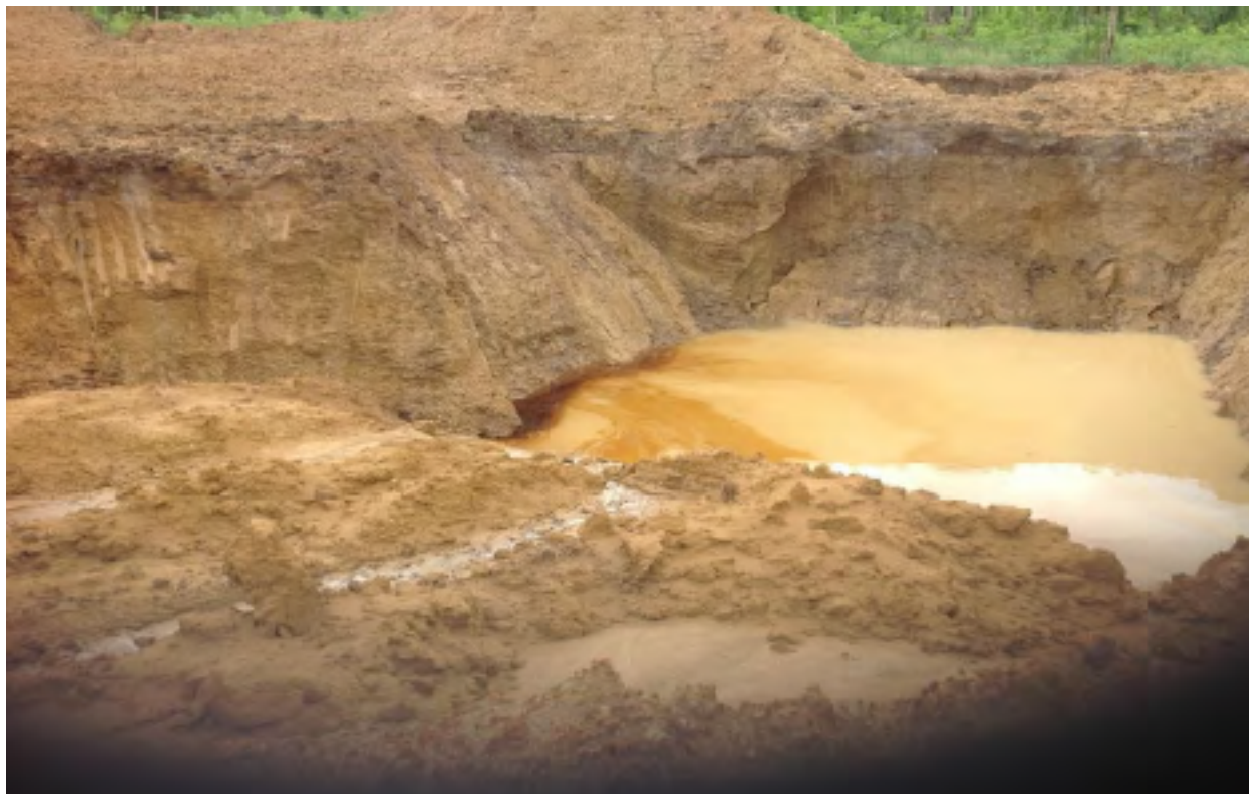
PIT7: BEFORE APPLICATION OF TREATMENT

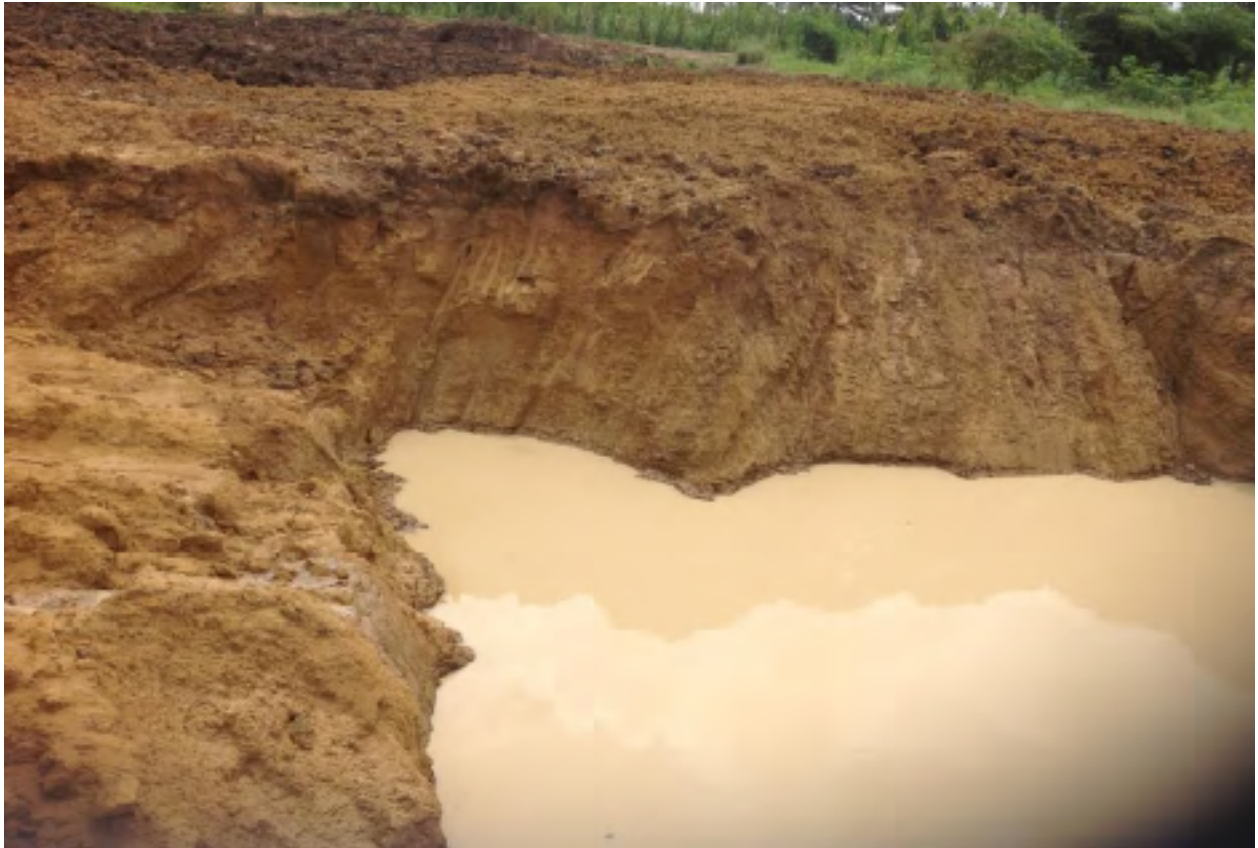
PIT7: AFTER APPLICATION OF OIL SPILL EATER II ON EXCAVATED PIT FOR TREATMENT OF GROUND WATER

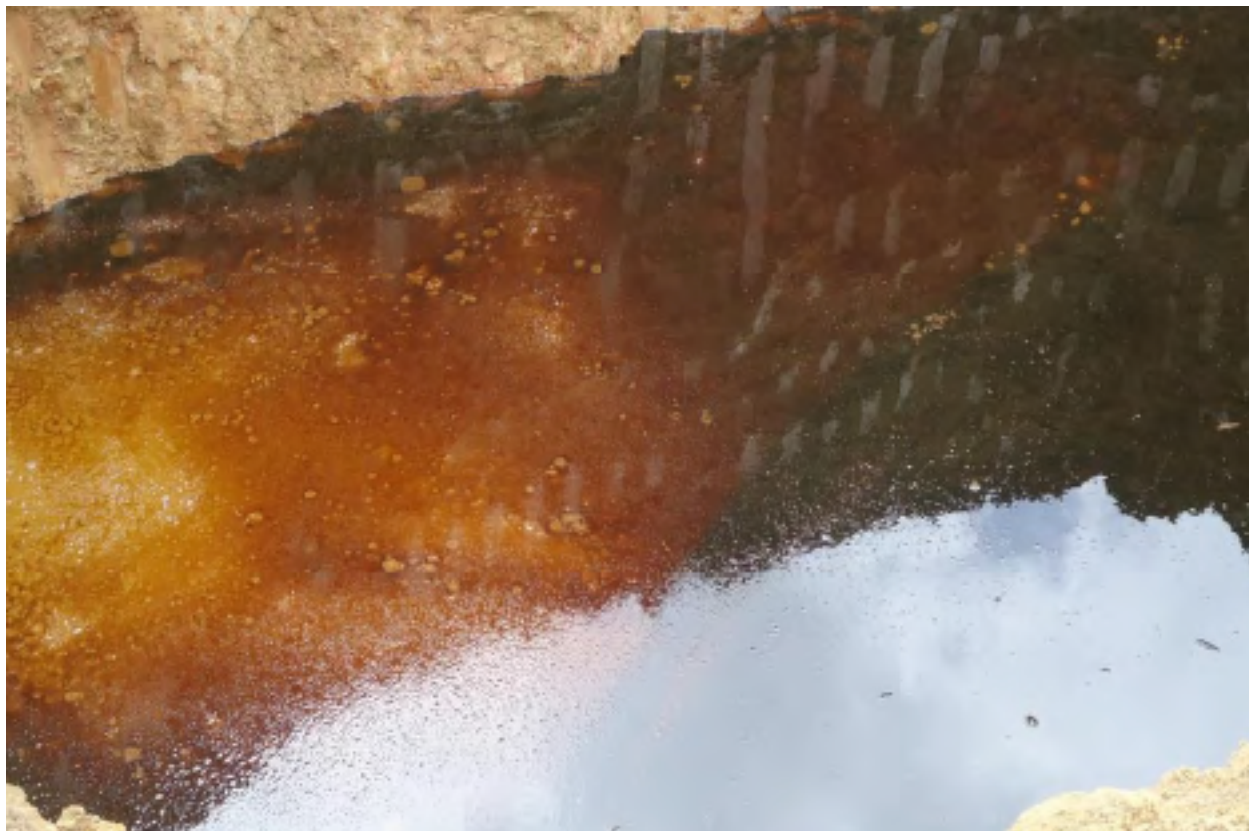
PIT8: BEFORE RECOVERY AND TREATMENT OF EXCAVATED PIT

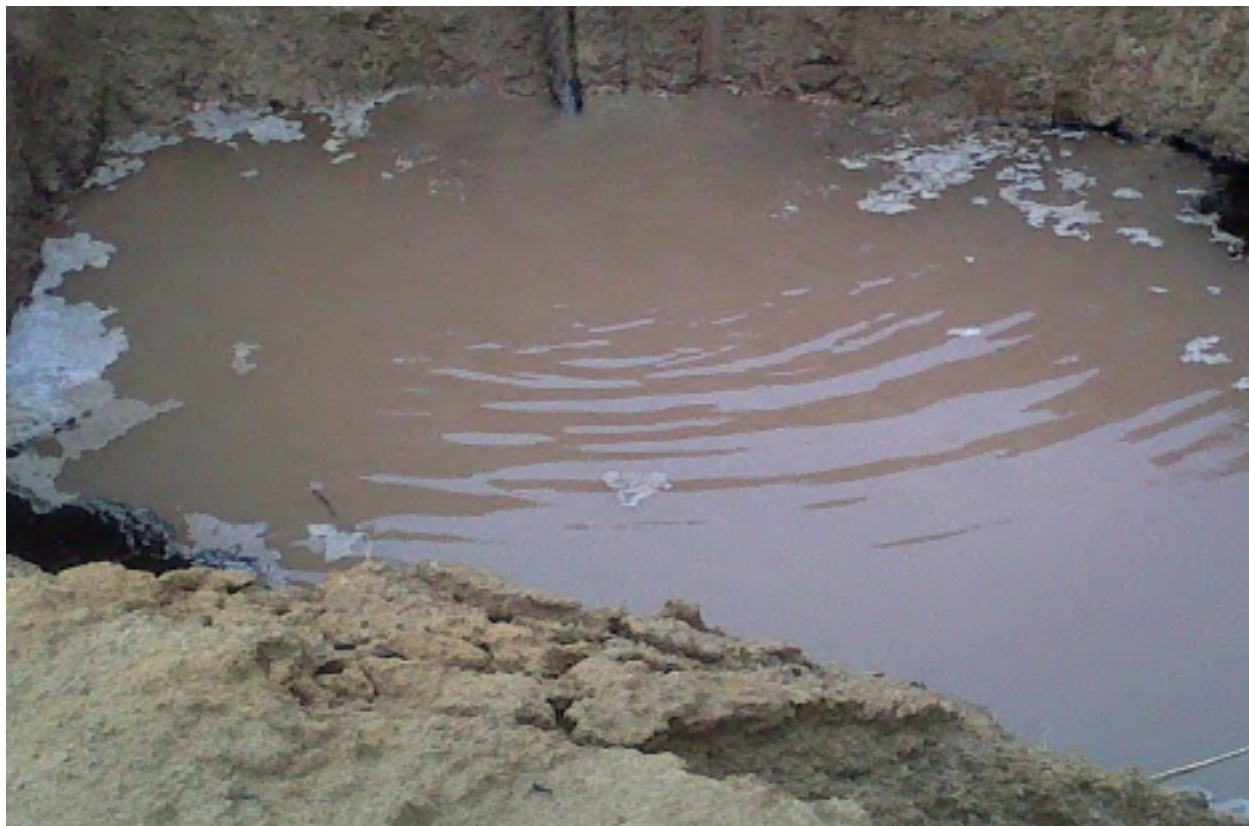
PIT8: IMMEDIATE REACTION AFTER RECOVERY AND TREATMENT WITH OSE

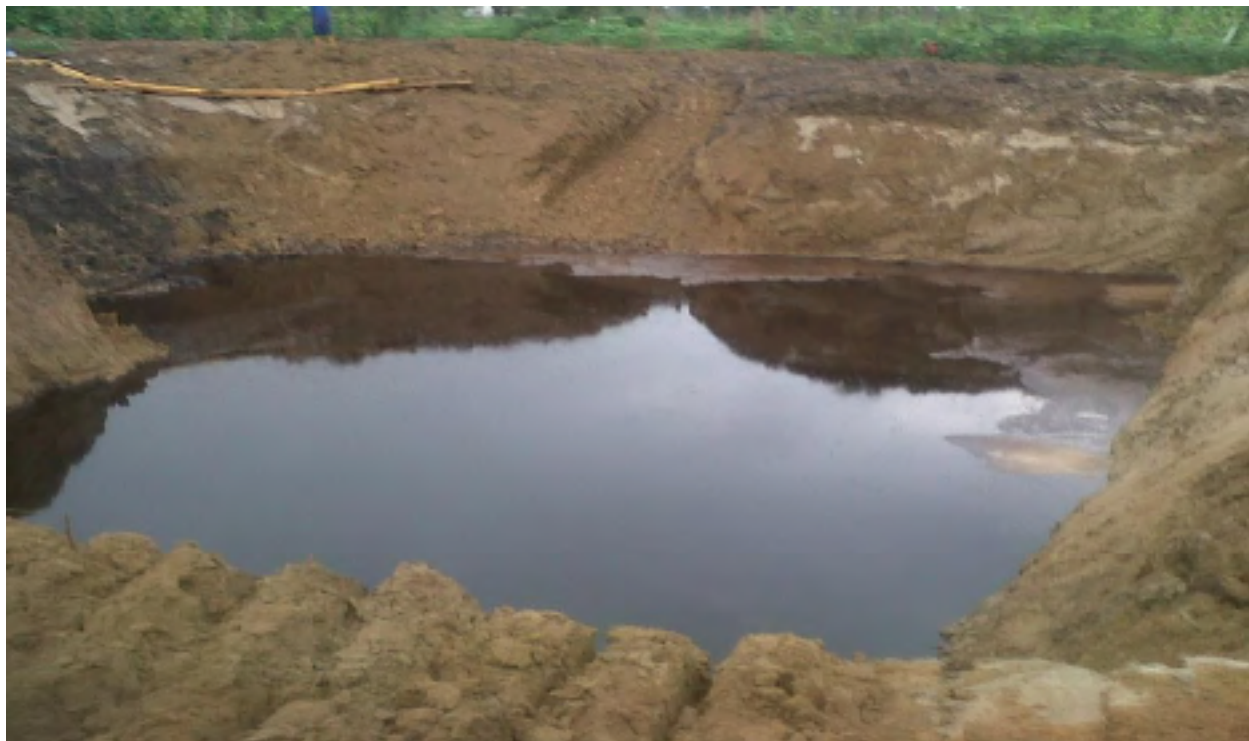
PIT9: EXCAVATED PIT WITH CRUDE BEFORE RECOVERY AND TREATMENT
