**FINAL PROJECT REPORT FOR CLEAN-UP AND
REMEDIATION**

24" Nkpoku Bomu Pipeline impacted area

BERA GOKANA

**INCIDENT NOS: 970940 & 950208 INCIDENT DATE: 27/03/2013 CONTRACT
START DATE: 10/04/2013 CONTRACT END DATE: 18/07/2013 PURCHASE ORDER
NO: 4510295312 CONTRACTOR: GIOLEE GLOBAL RESOURCES NIG. LTD., and the
OSEI Corporation
WORK COMPLETION CERTIFICATION**

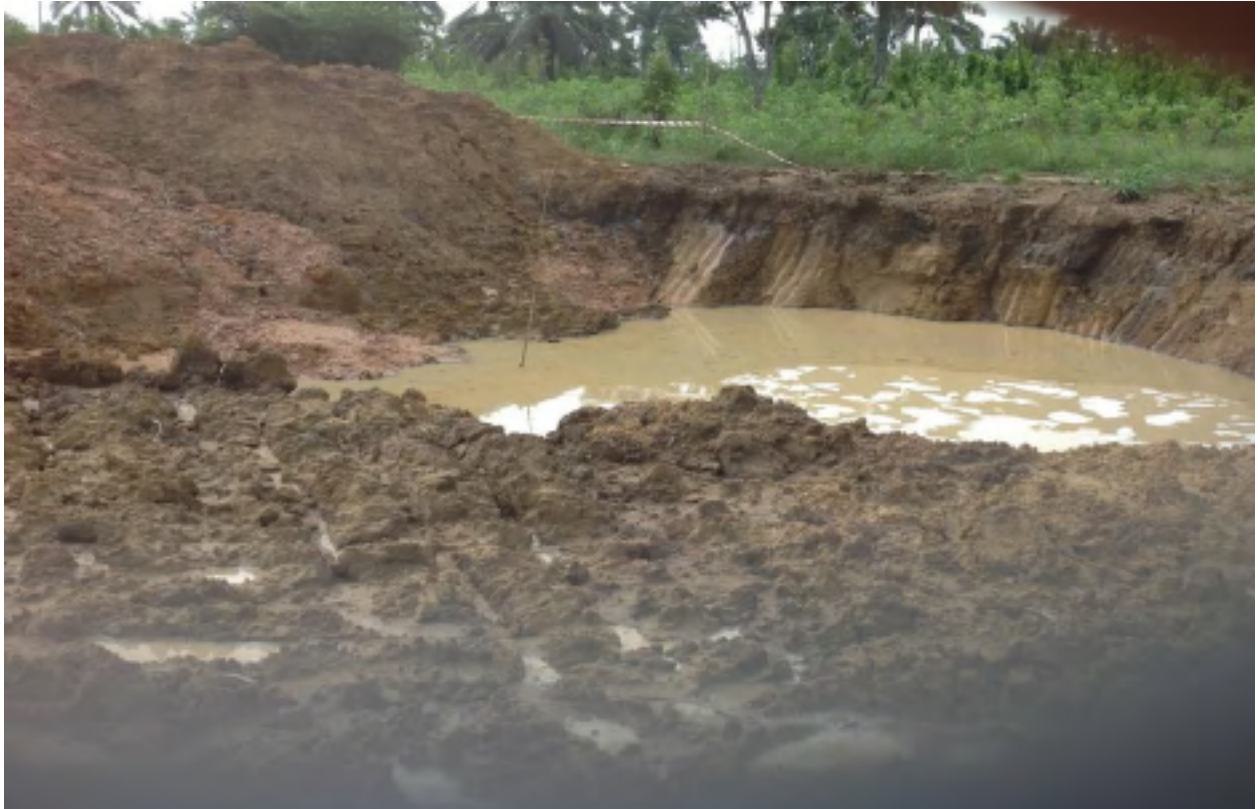
PIT9: AFTER RECOVERY AND APPLICATION OF TREATMENT ON EXCAVATED PIT

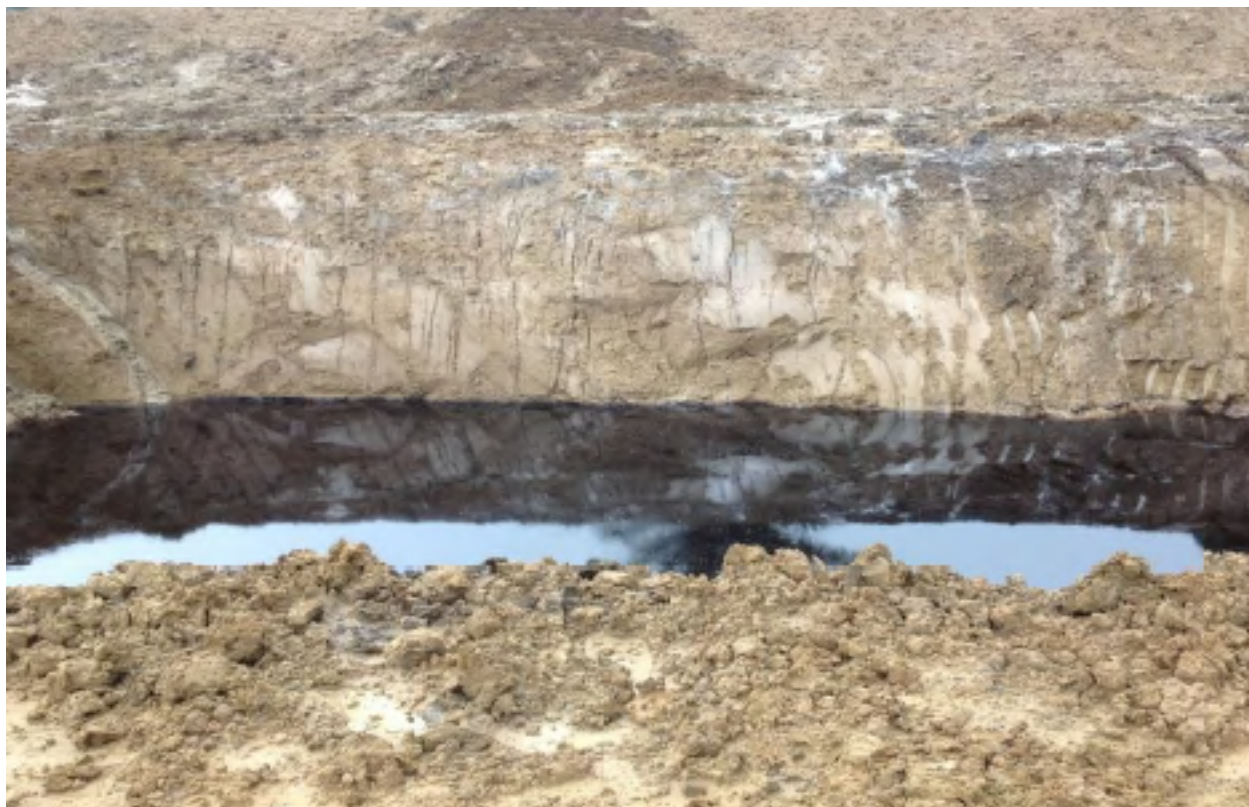
PIT10: EXCAVATED PIT ON SHELL ROW CLOSE TO THE PIPE, BEFORE RECOVERY AND TREATMENT

- Community uses part of the site as access road.
- Community harassment at site.
- Difficulty in managing community labour to comply with HSE rules and procedures.
- Weather condition.
- Removal/Management of heavily impacted sludge with stony carbonized material.
- During remediation near the life pipeline on ROW we were unable to expose the pipe and remove carbonized materials left under the pipe which might pose a threat to the area overtime because permit was not granted for that purpose.

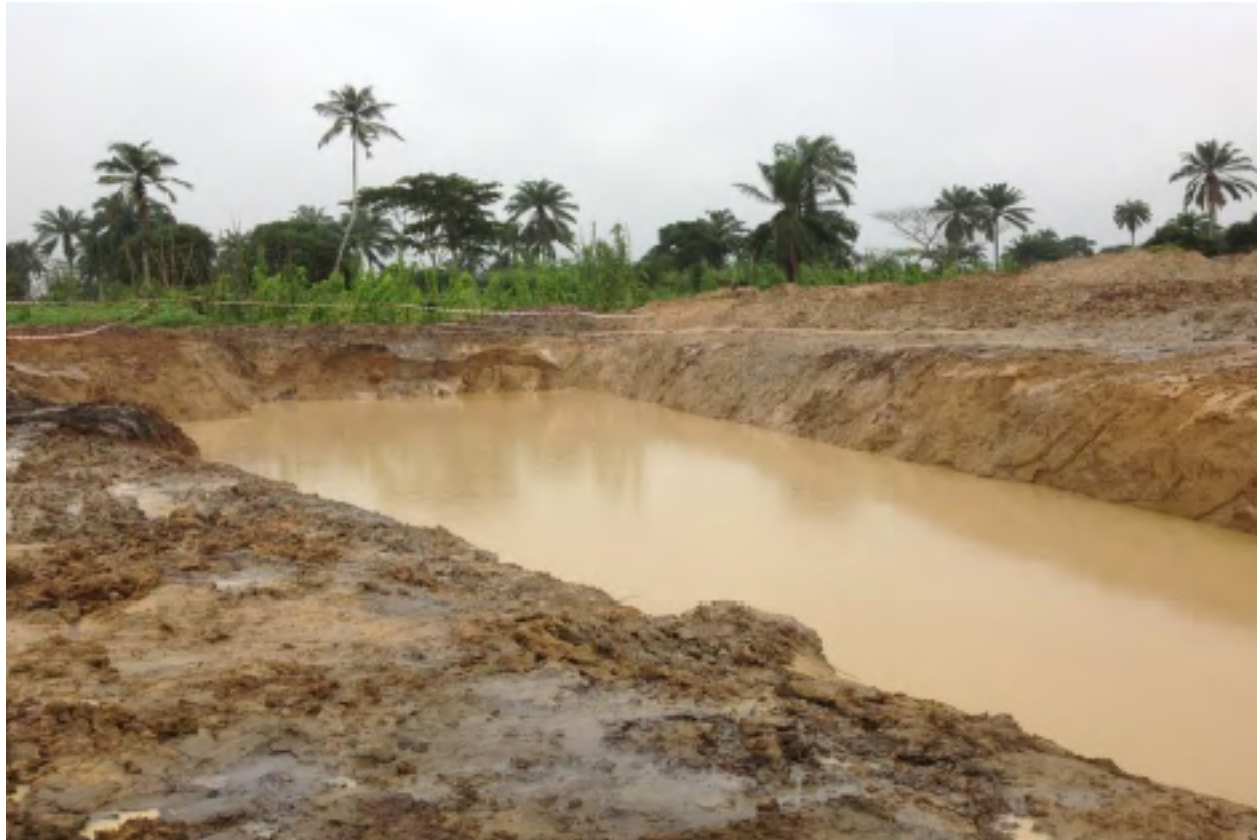
PIT10: AFTER RECOVERY OF CRUDE AND TREATMENT OF EXCAVATED PIT WITH OIL SPILL EATER II

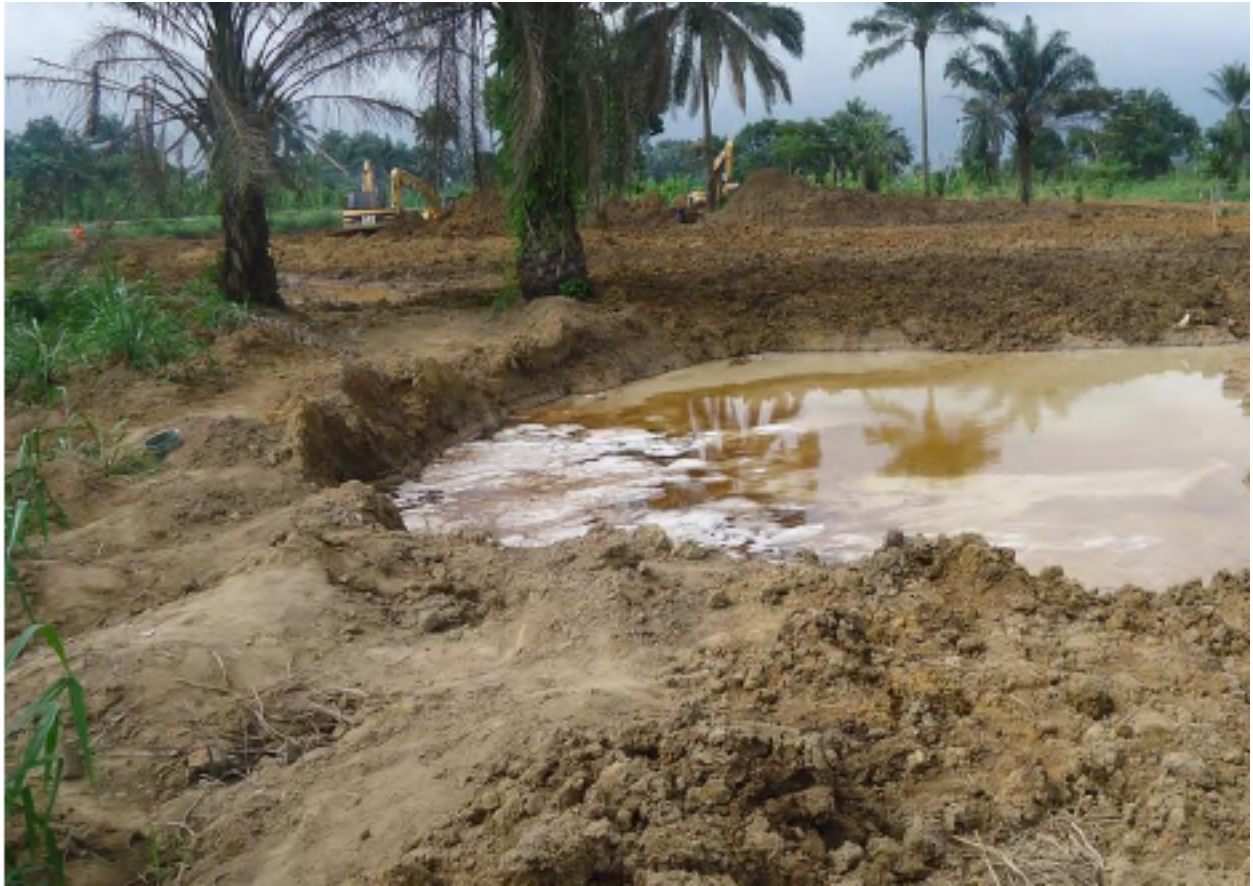
PIT11: BEFORE RECOVERY AND TREATMENT OF EXCAVATED GROUND WATER WITH OSEII

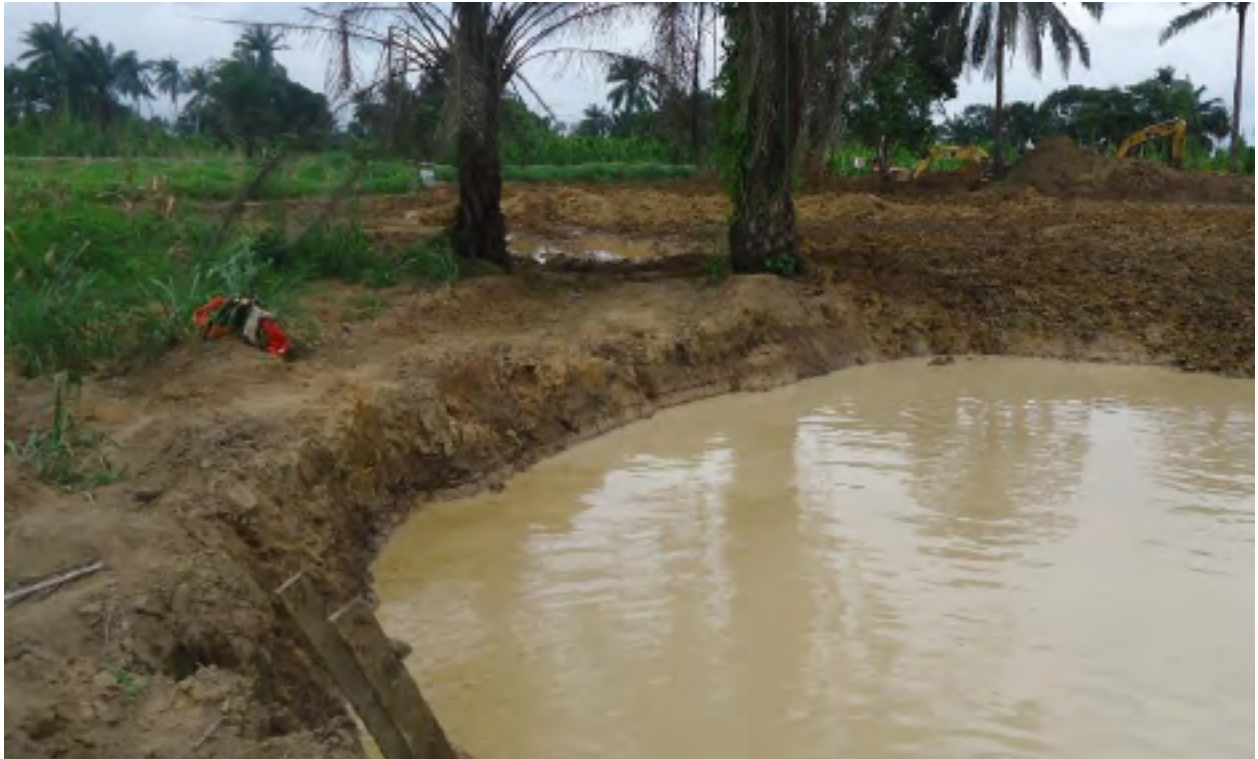
PIT11: AFTER RECOVERY AND TREATMENT OF EXCAVATED GROUND WATER WITH OSE II

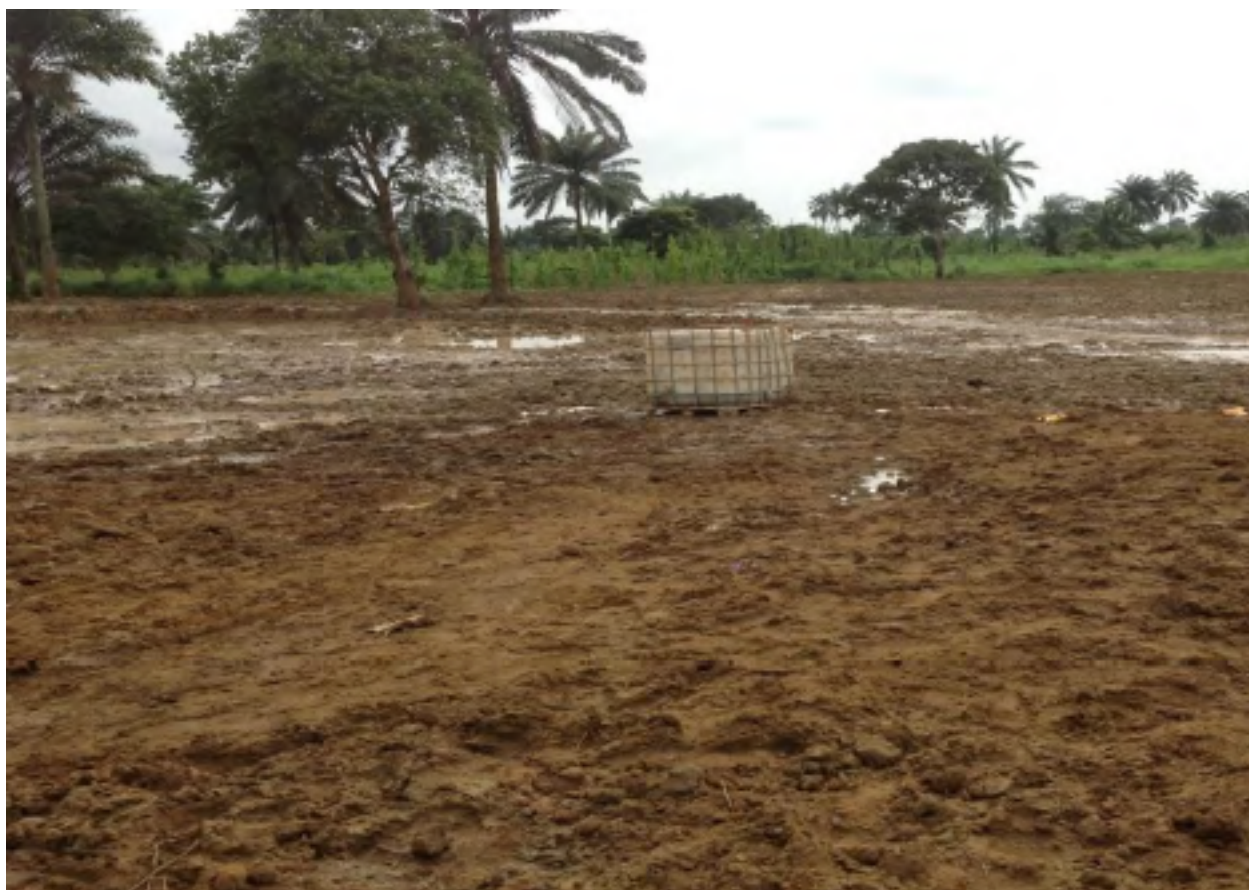
**VIEW OF SITE AFTER GROUND WATER TREATMENT AND BACKFILLING OF
VARIOUS PITS WITH TREATED SOIL**

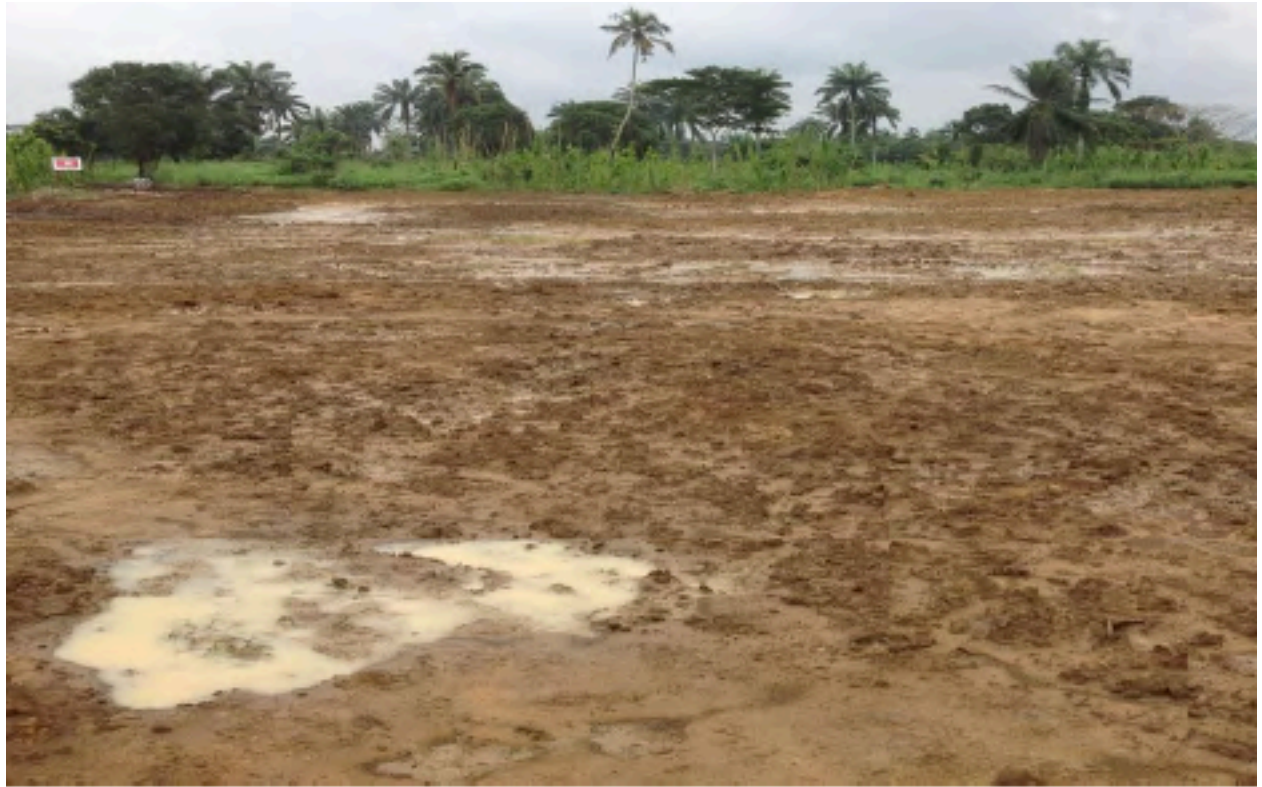
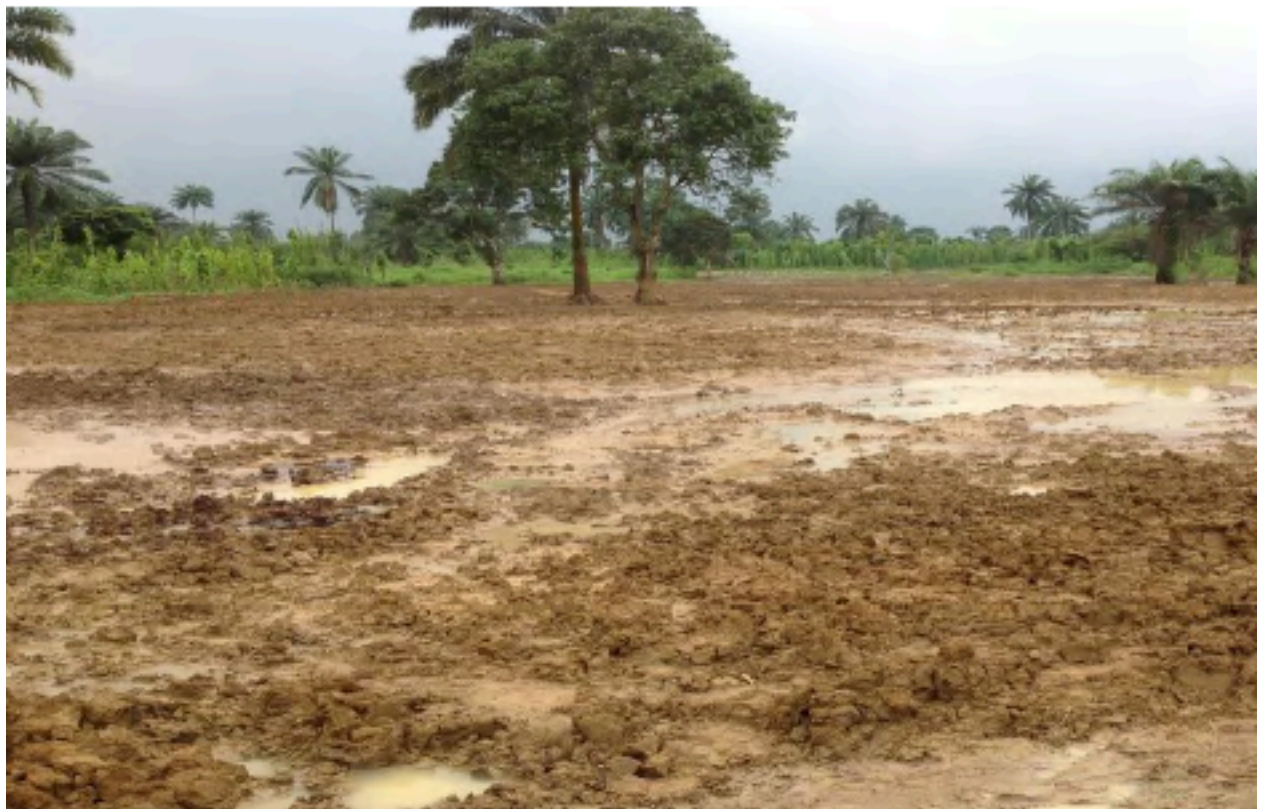
OVERVIEW OF SITE AFTER APPLICATION OF TREATMENT AND WORK ON SITE
