CLEAN-UP AND REMEDIATION ACTIVITY REPORT

CAWTHORNE CHANNEL 1 FLOW STATION

GIOLEE GLOBAL RESOURCES LIMITED

SHELL PETROLEUM DEVELOPMENT COMPANY OF NIGERIA LIMITED

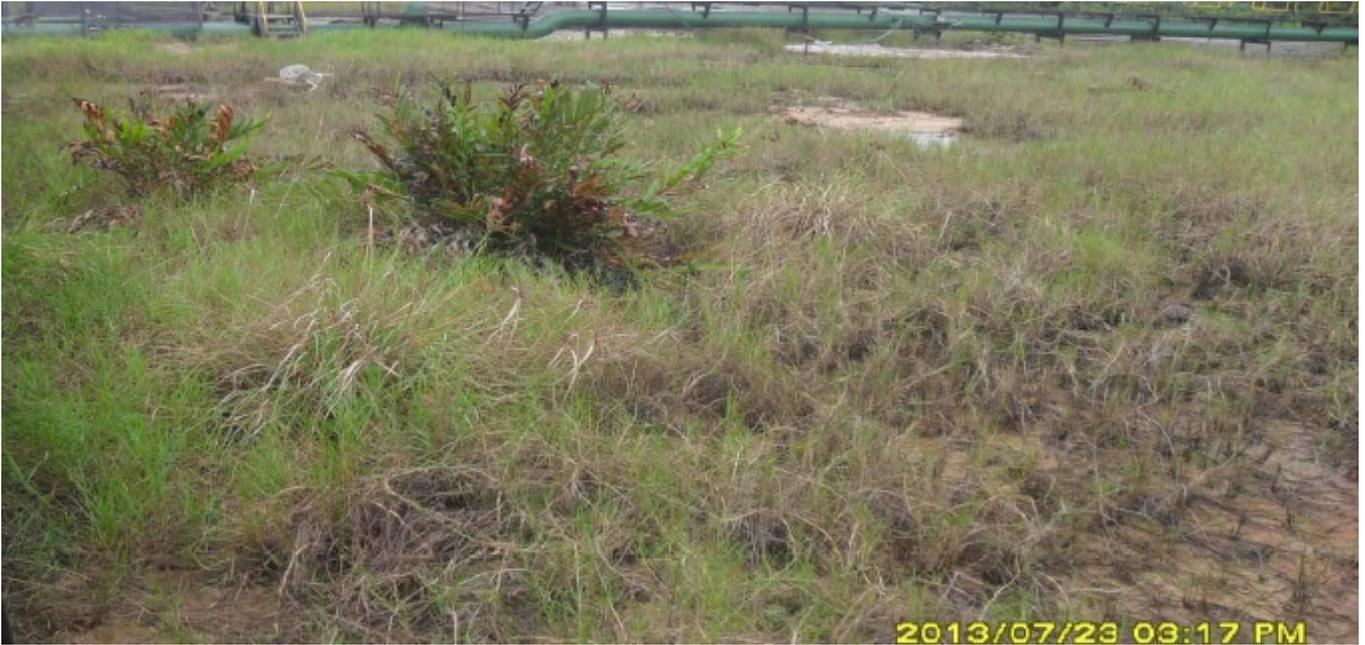
Fig.1: Initial site picture (Section A)

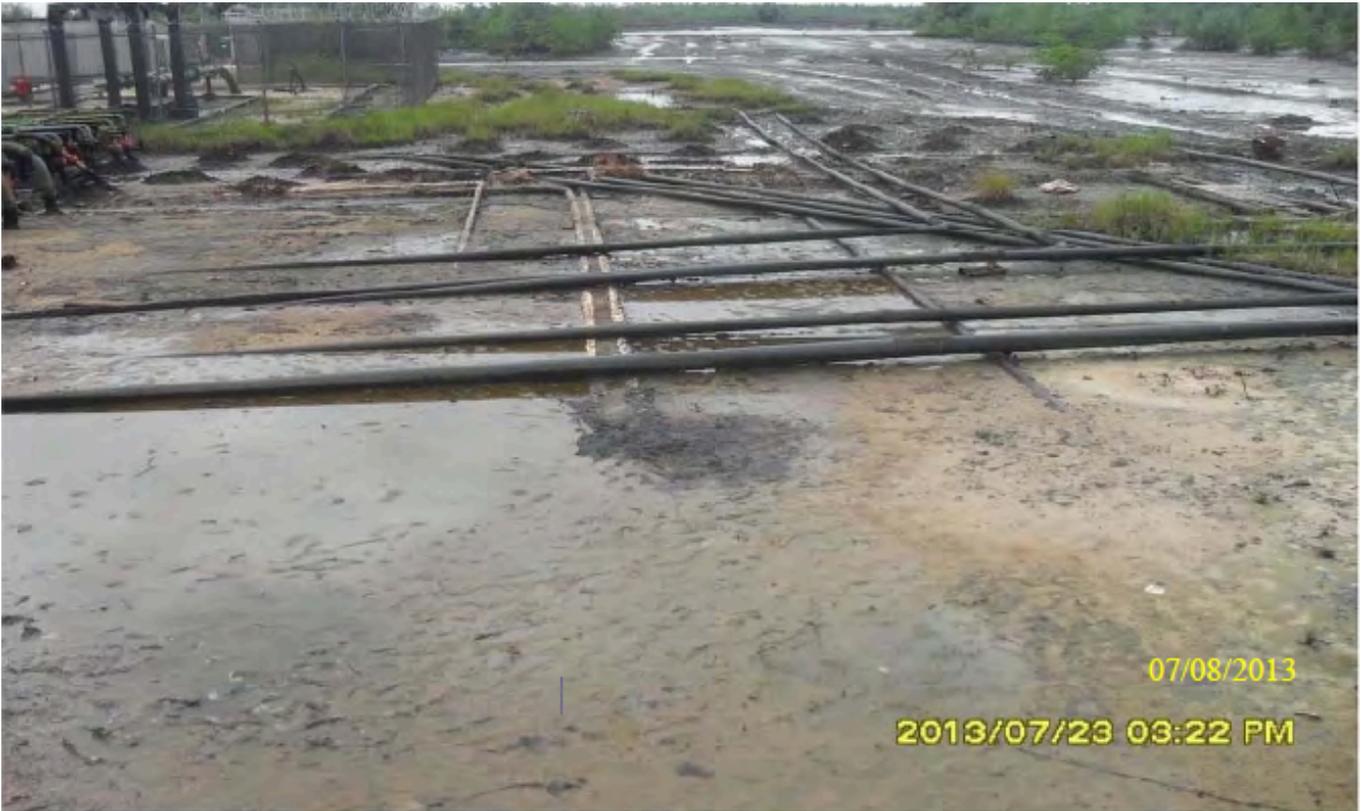
Fig. 2: Initial site picture (Section B)

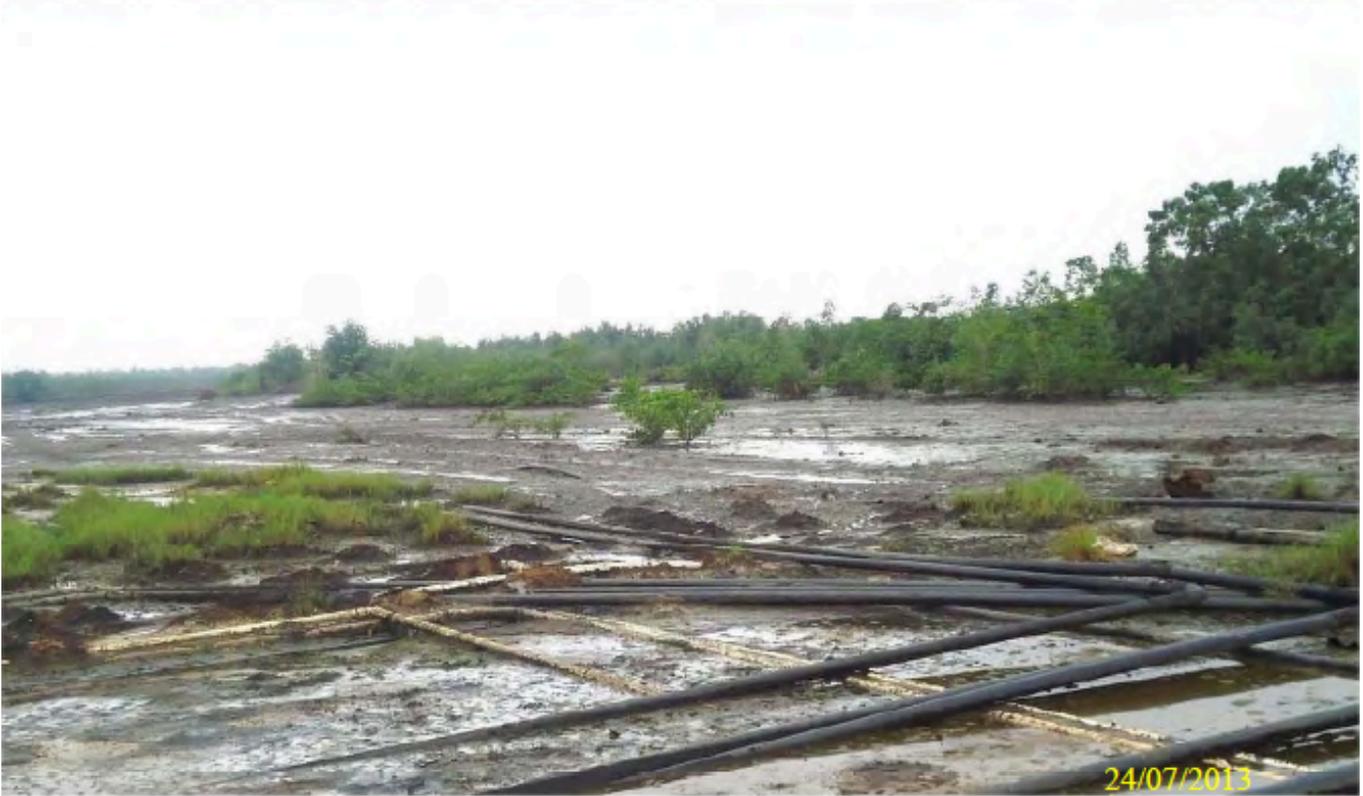
Fig 3: Initial site picture

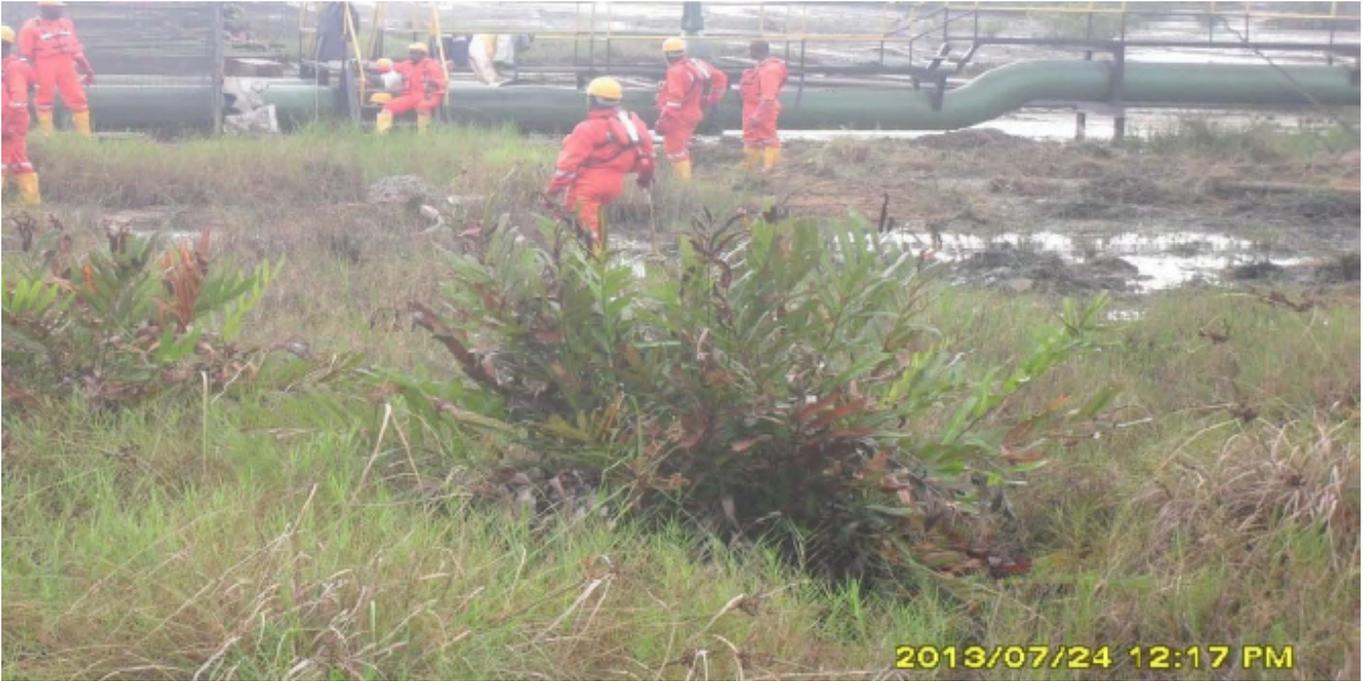
Fig 4: Initial site picture

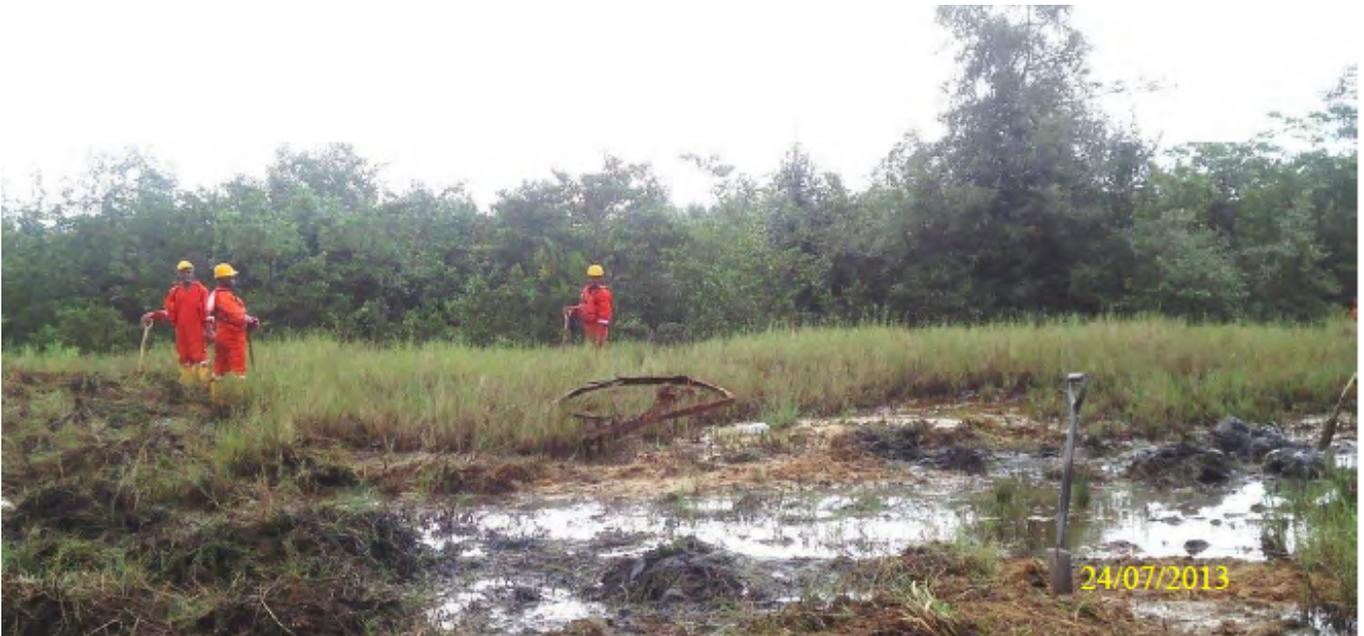
Fig. 5: Cleaning of impacted vegetation(Section B)

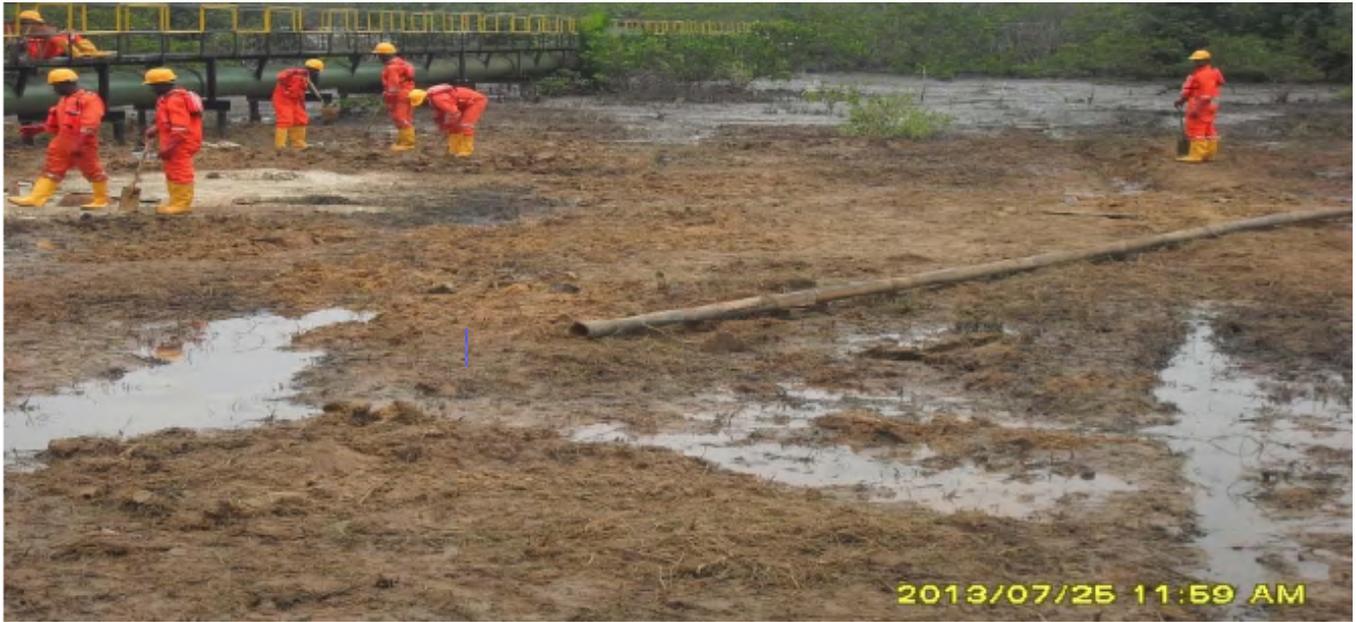
Fig. 6: Tilling of impacted soil (Section A)

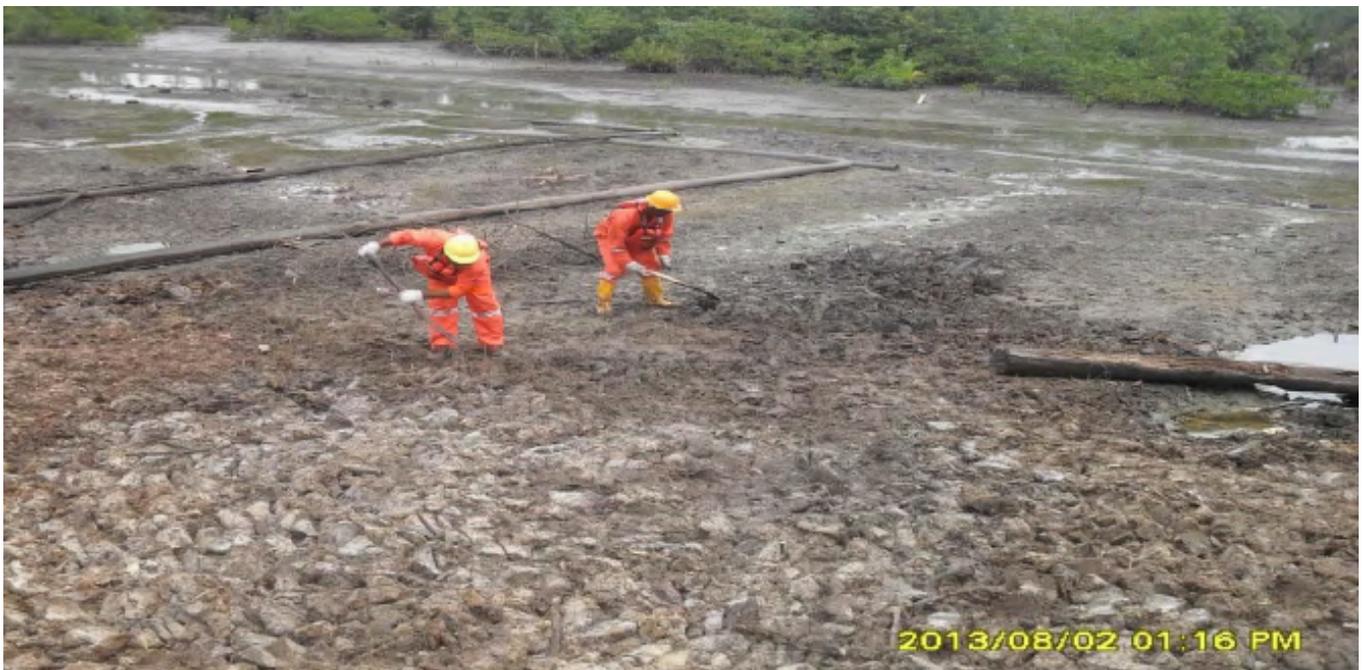
Fig. 7: Tilling of impacted soil (Section B)

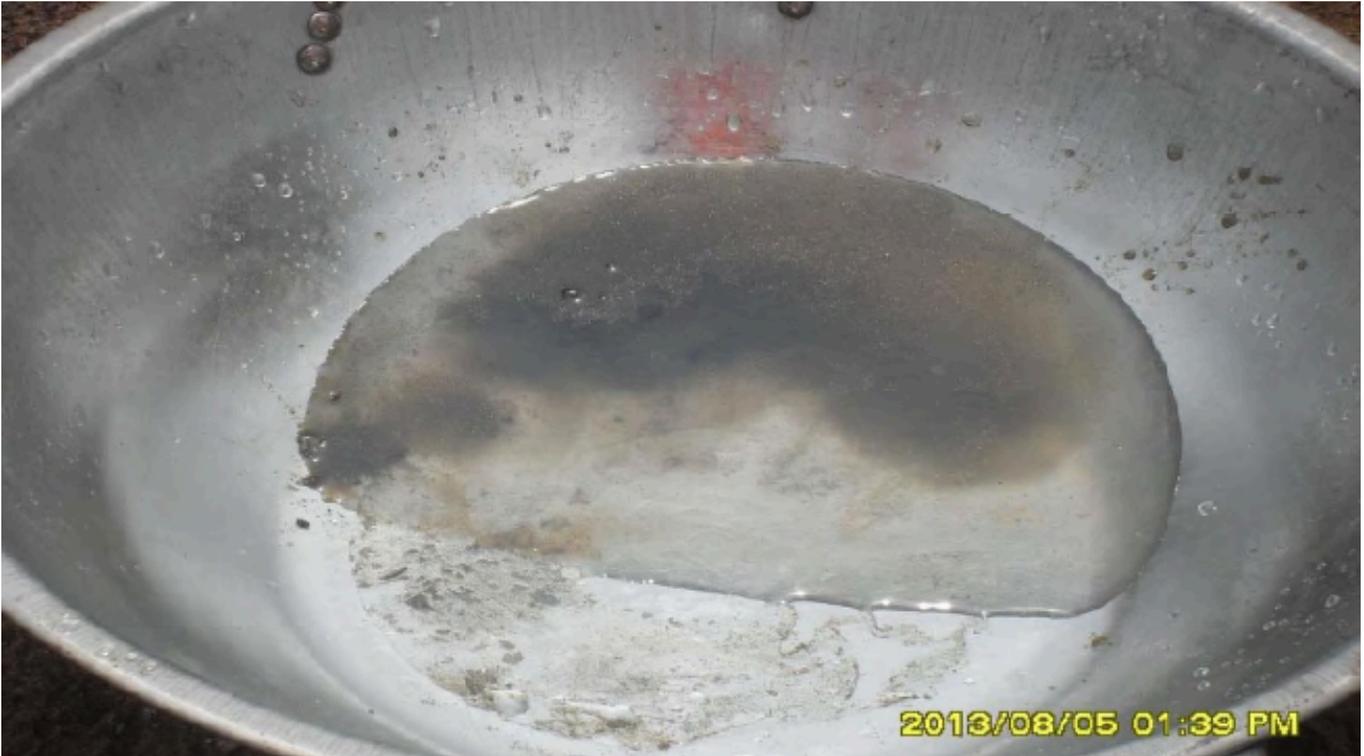
Fig. 8: Oil sheen test at 50% of the job.

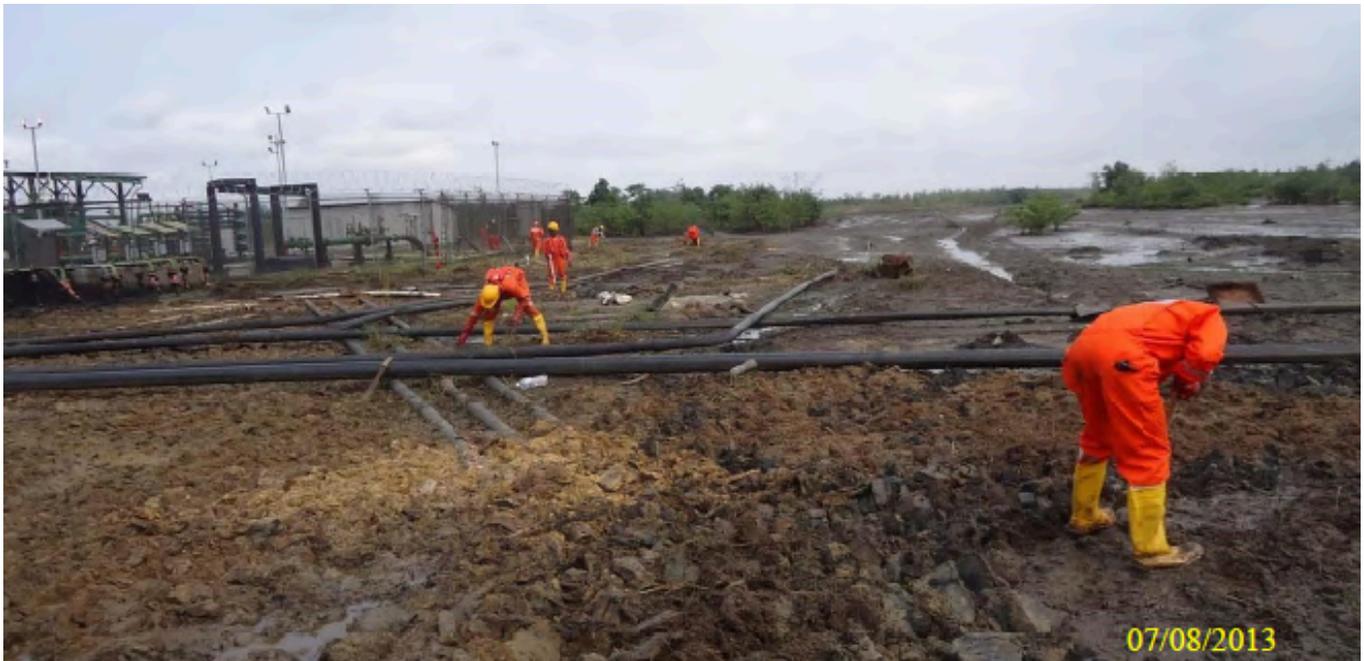
Fig. 9: Tilling in progress

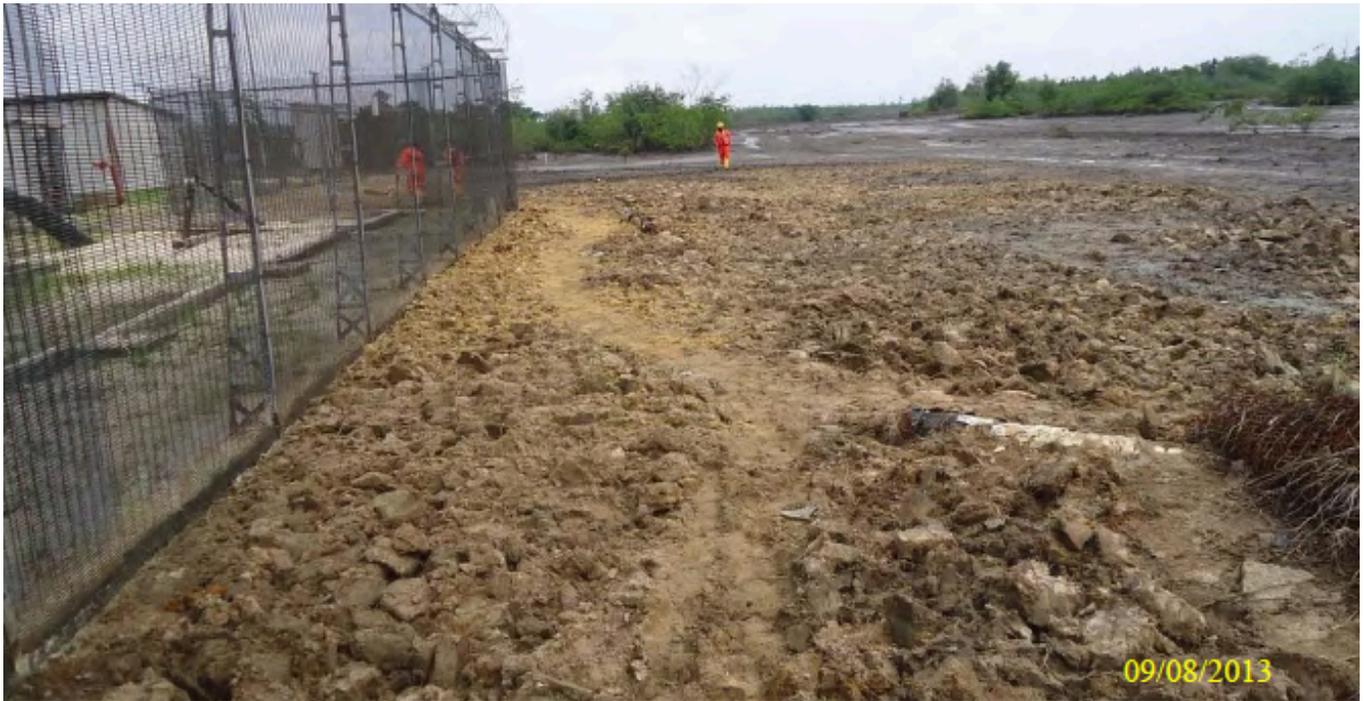
Fig 10: Tilled soil

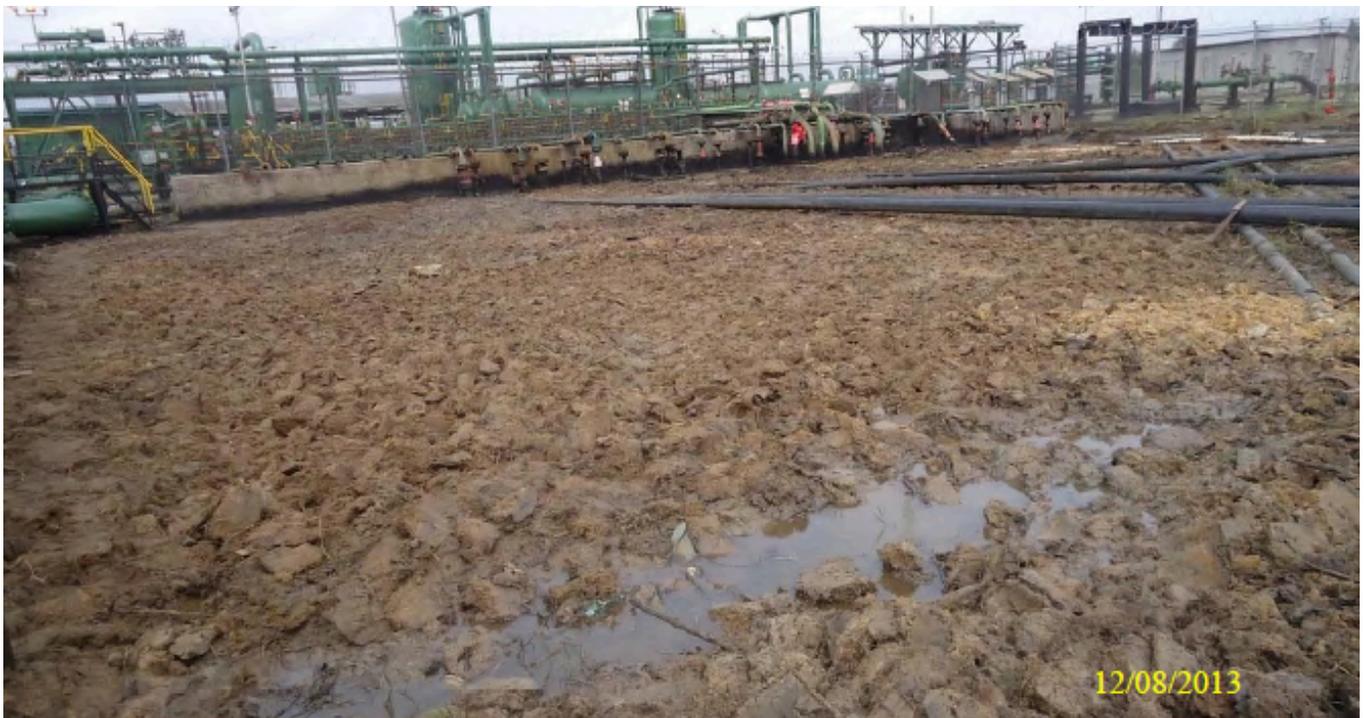
Fig. 11: Tilled soil awaiting homogenization

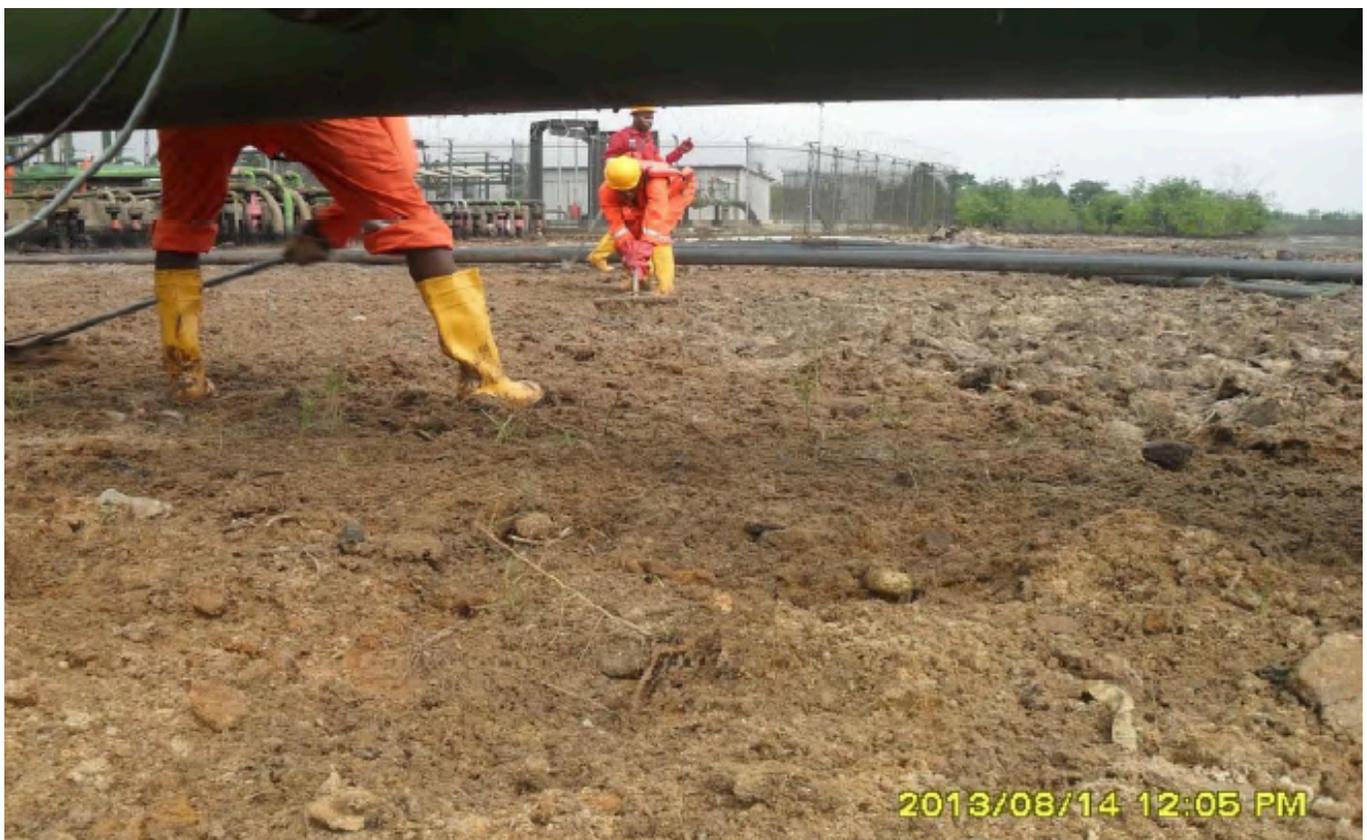
Fig. 12: Homogenization of tilled soil (Section B)

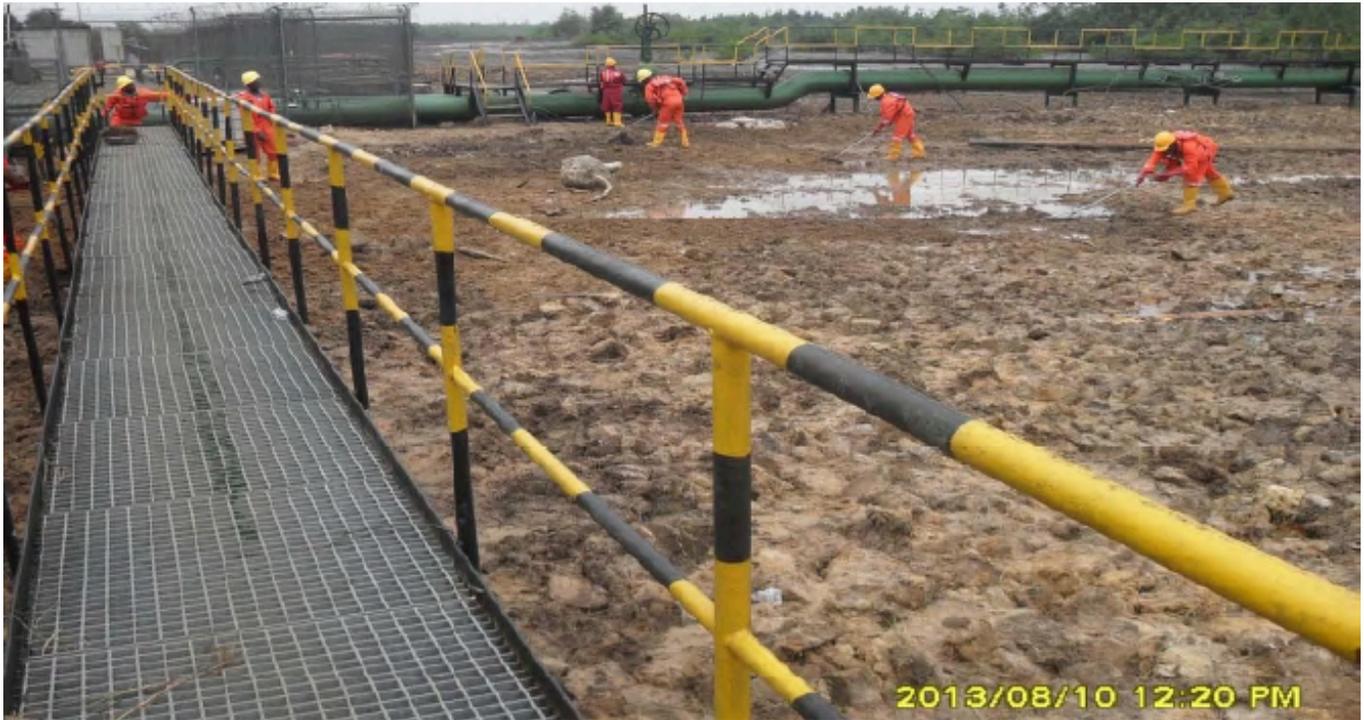
Fig 13: Homogenization of tilled soil.(Section A)

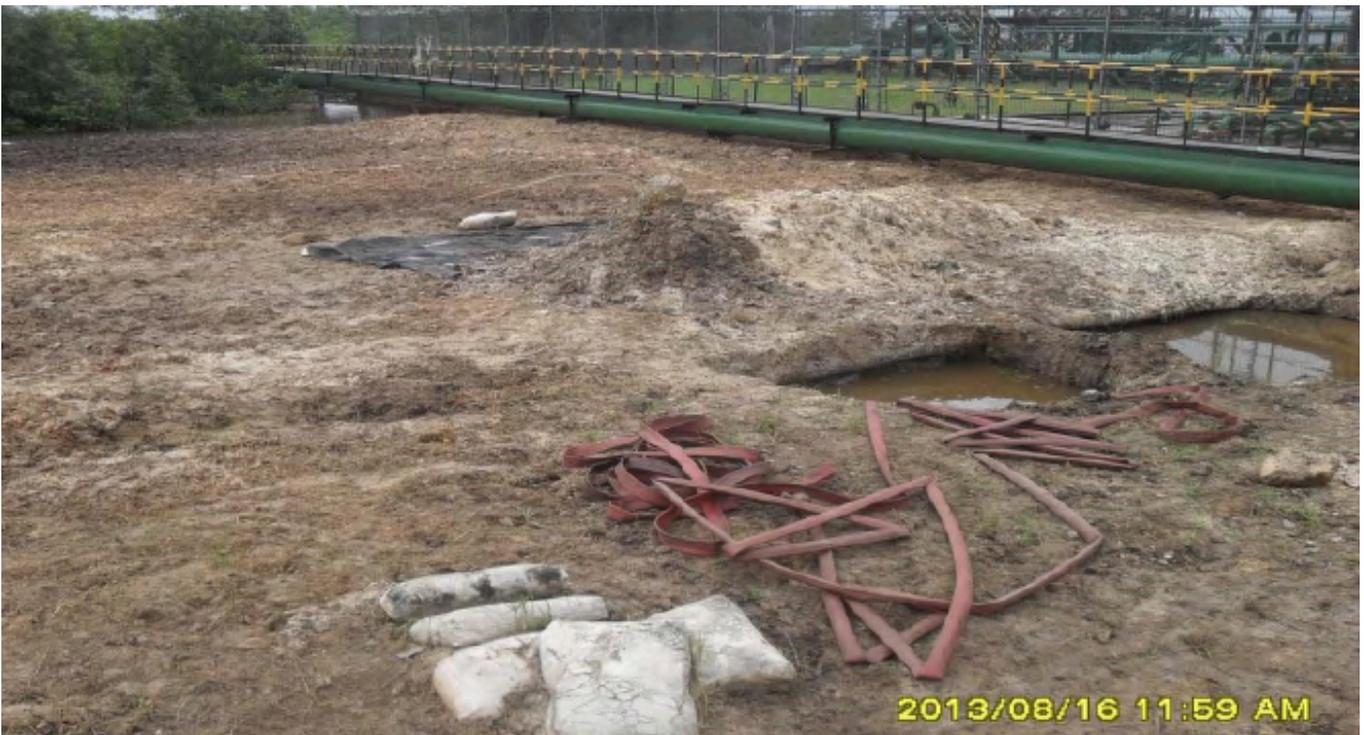
Fig. 14:Excavated materials on liner (Section A)

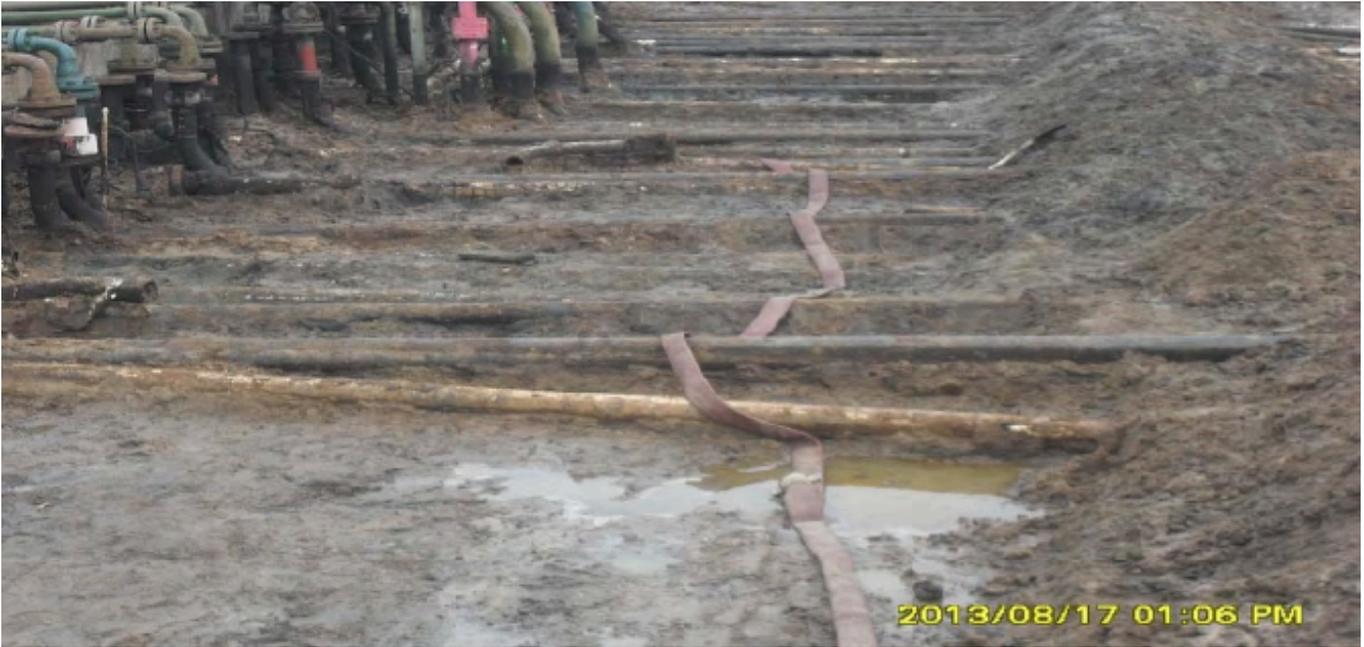
Fig. 15: Excavated materials (Section B)

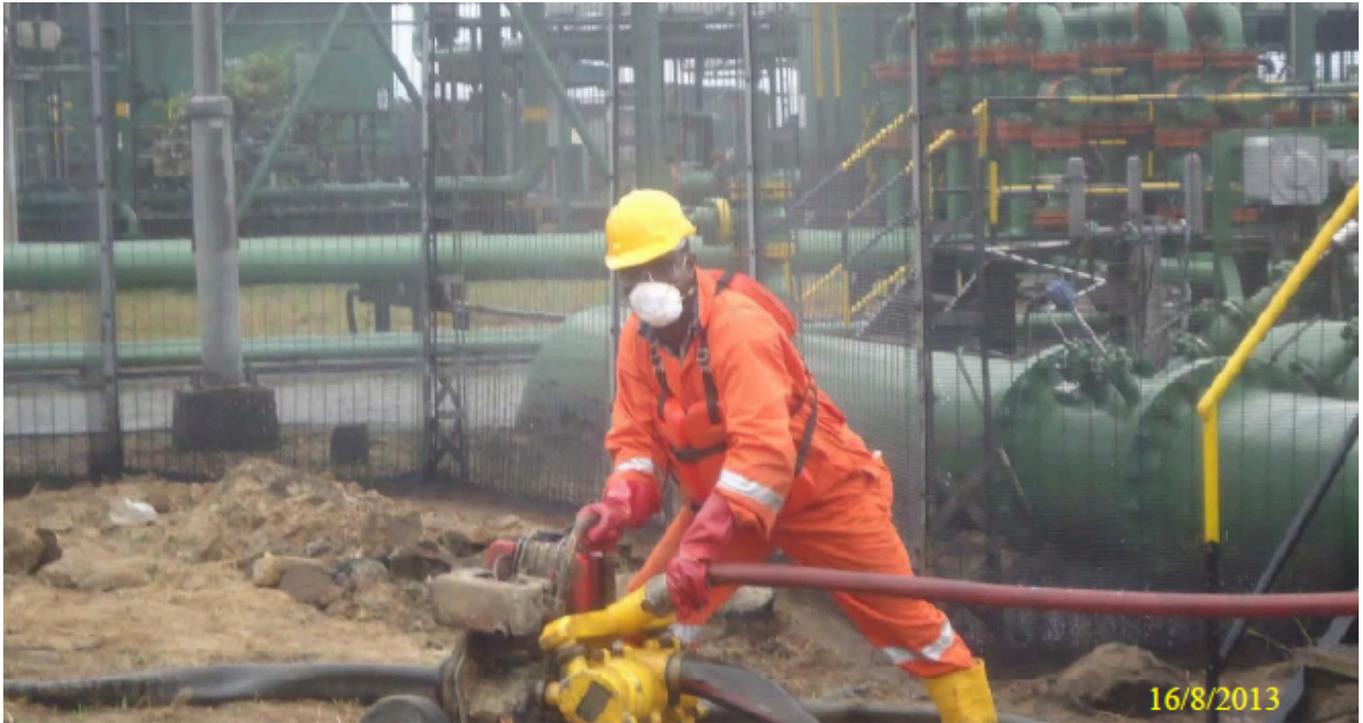
Fig 16: Pump used for application of oil spill eater 11

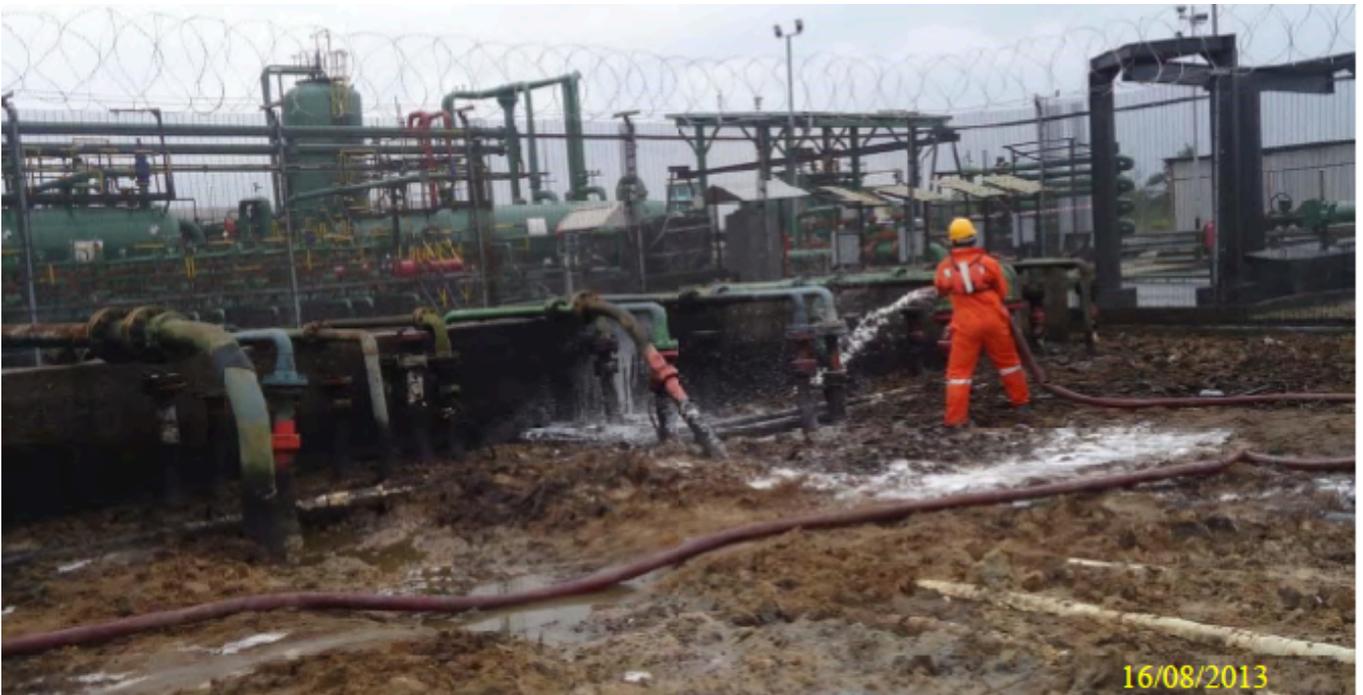
Fig 17: Oil spill eater 11 being applied on impacted tilled soi

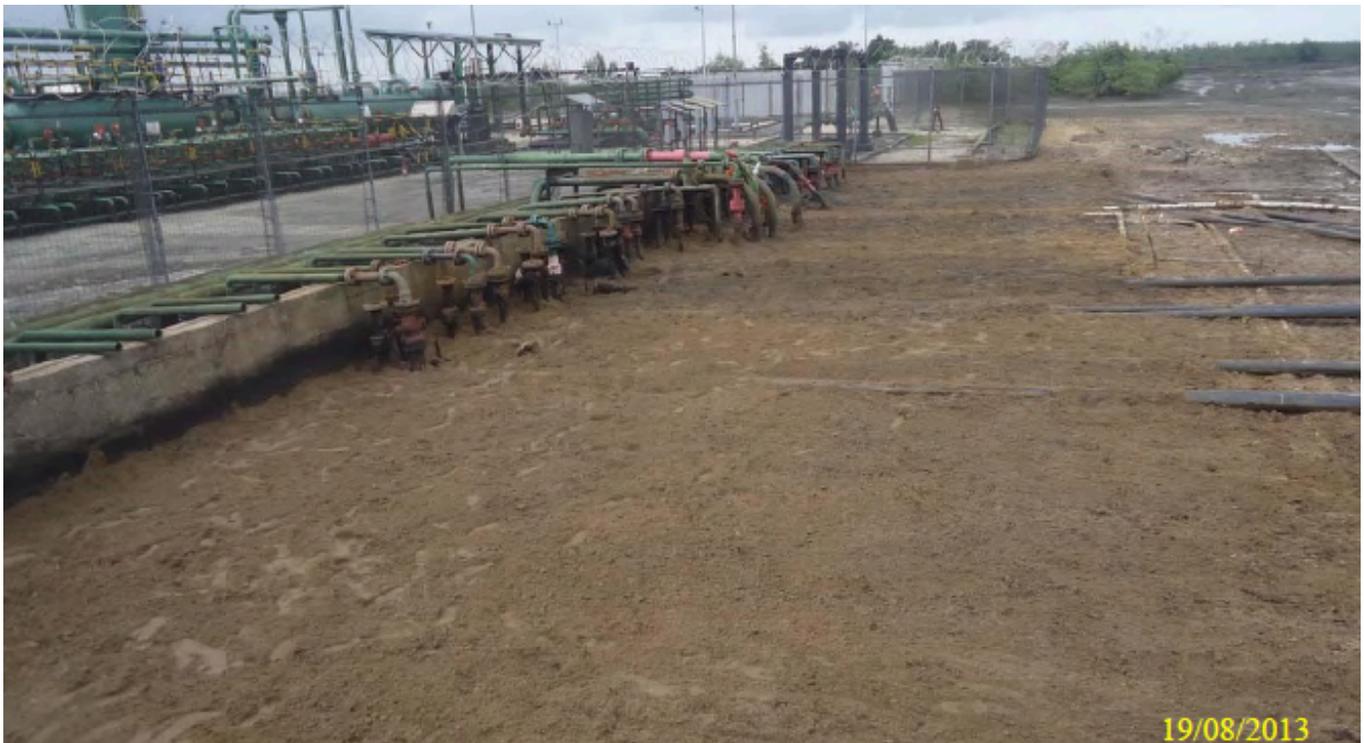
Fig 18: Final look of the Cawthorne channel 1 flow station after work is completed

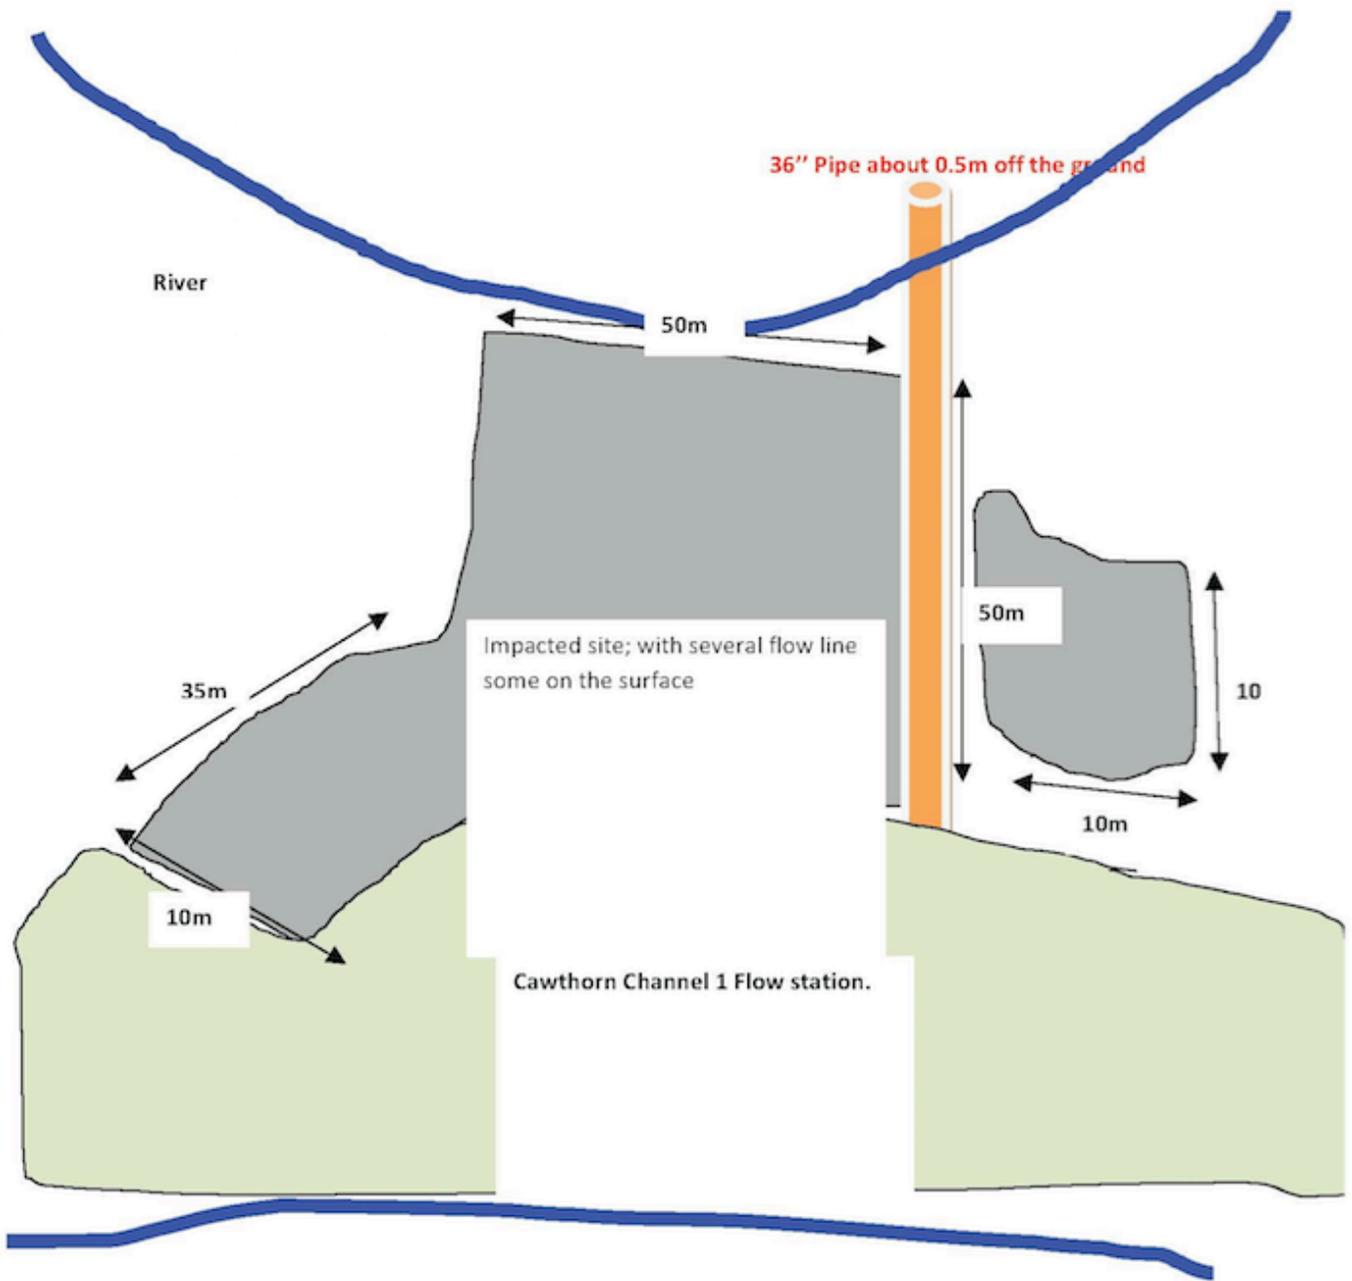
General Comments/Observations
<p>The site is located right at the back of Caw Channel 1 Flow Station; along the Flow Line ROW. The flow lines lead into the inlet manifold.</p> <p>Site appear to have suffered several generations of spill from 2008 when it was first reported till the date of this assessment. Assessment was first carried out in June 2011.</p> <p>Further release of oil possible from the flow station inlet manifold added to the impact.</p> <p>The most probable source of the spill is the Caw Channel 1 inlet manifold. Oil released from this facility flow downstream to impact the immediate surroundings. Cut flow lines that litter the place may also be a source of spill.</p> <p>Care must be taken working here because there are several flow line some are on the surface while other are buried but very shallow.</p>
<p>Lithology: The basic soil type is silty Sand.</p>
<p>Ground Water: was encountered at 0.5m, but it was not impacted.</p>

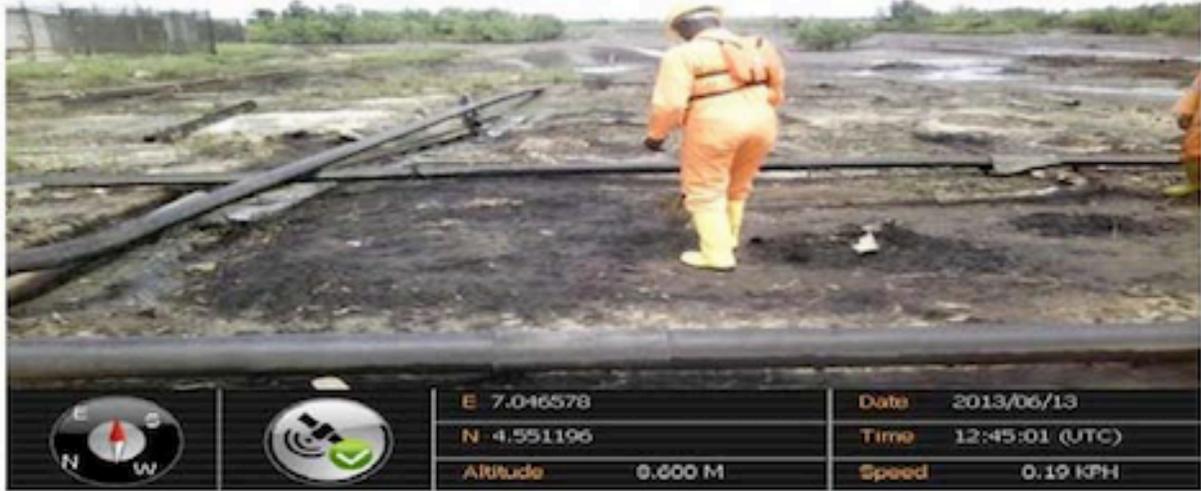
An overview of site

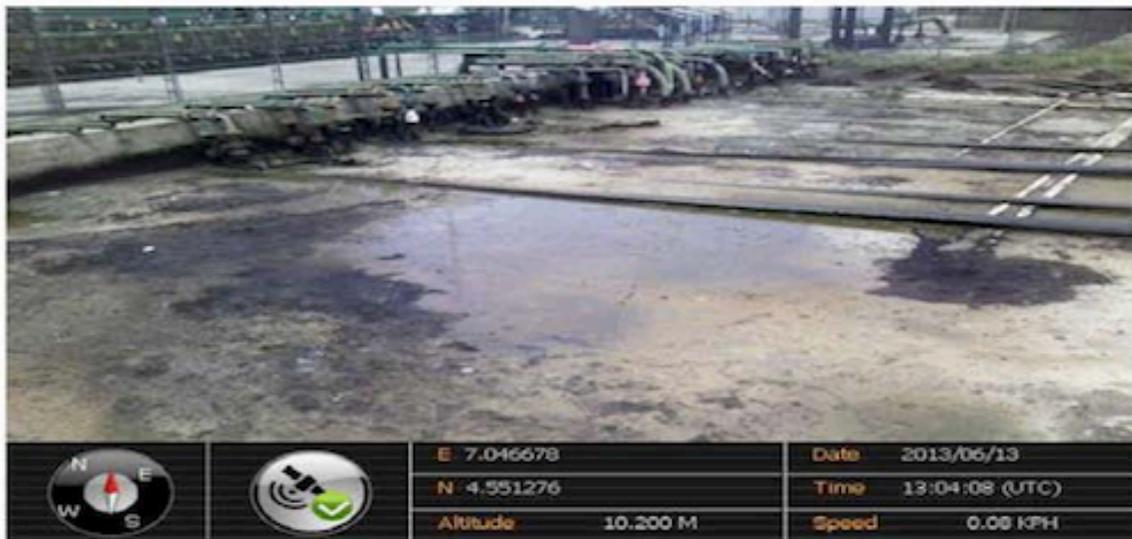
The inlet manifold and it's immediate surrounding

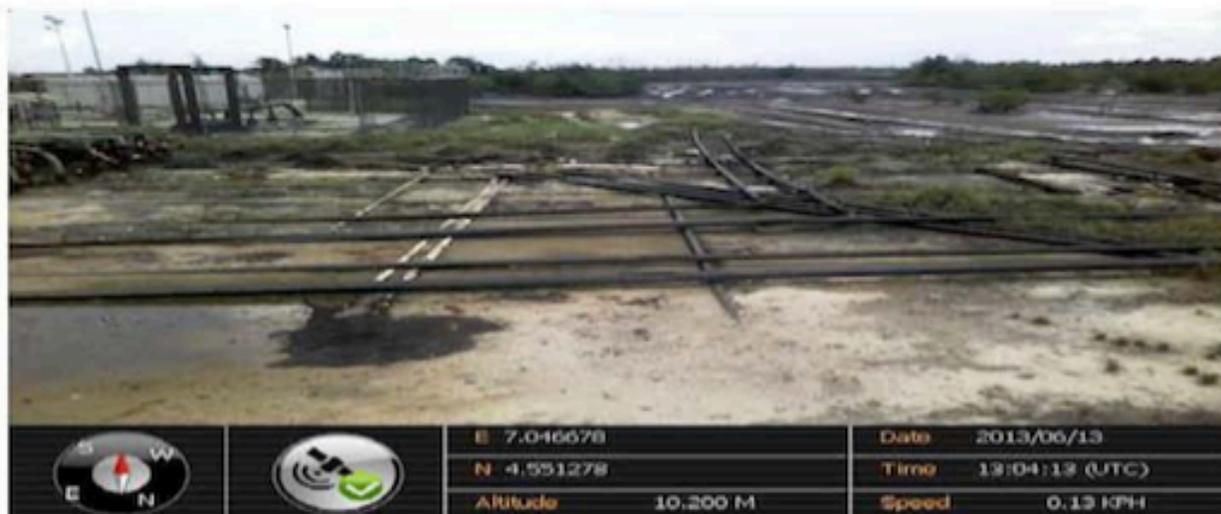
Showing site with net work of flow lines

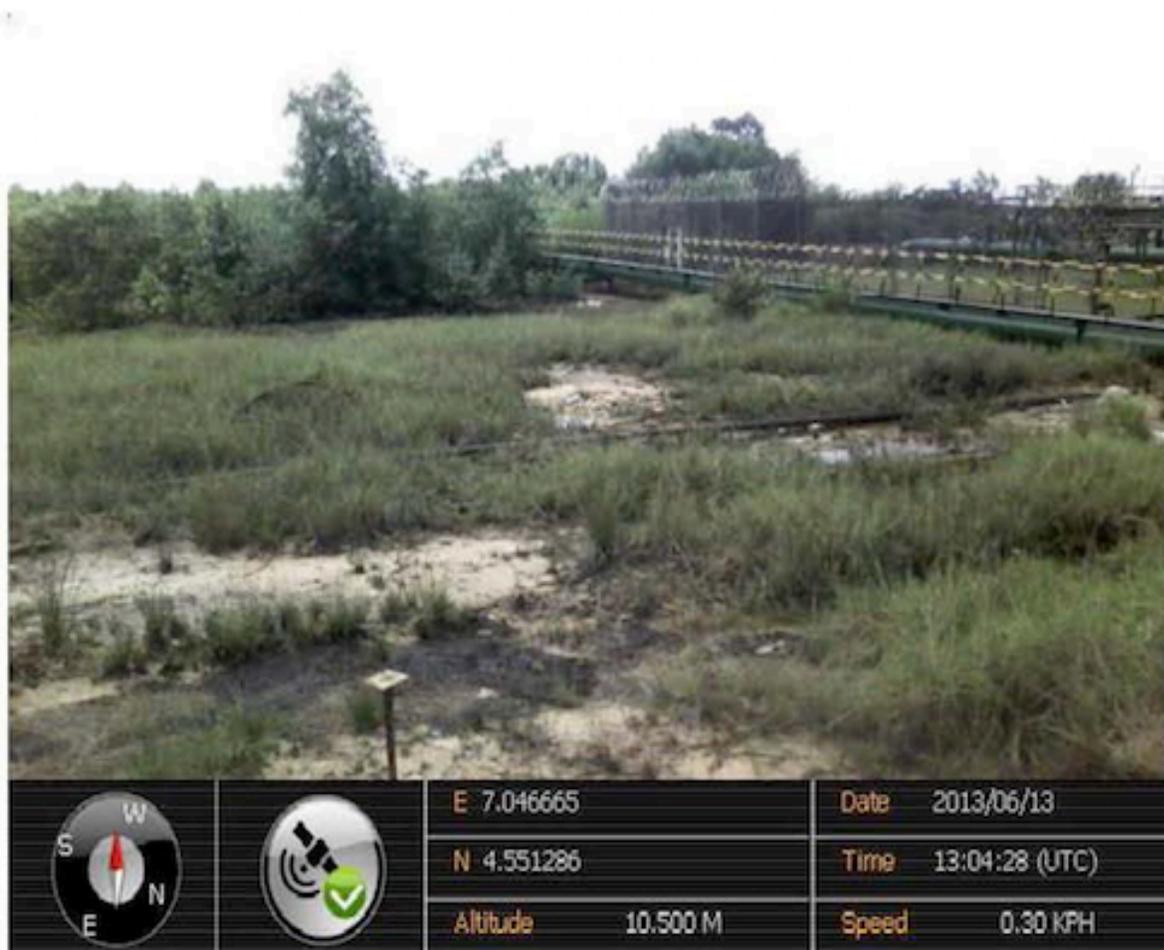
Isolated Pockets of impacted soil within an area with green grass.
