AT&T Alaskom Utilizing OSE II for Eight Different Regions of Alaska

EXECUTIVE SUMMARY

Eight AT&T facilities in southeast Alaska were visited and environmental samples collected and analyzed to determine whether past fuel handling practices have resulted in fuel impacts to site soils and surface water (if present) within and around the existing fuel containment structures. The eight facilities include Angoon, Bessie, Gunnuk, High Mountain, Mount Ripinski, Point Howard, Ratz Mountain, and South Passage. The results of the sample analyses from these sites indicate that each of the facilities have concentrations of diesel range organics (DRO) in the soil that exceed cleanup levels established by the Alaska Department of Environmental Conservation (ADEC) and will require remediation to achieve the cleanup levels. The High Mountain and South Passage sites also had concentrations of one polynuclear aromatic hydrocarbon (PAH) compound (dibenzo(a,h)anthracene) in the site soils that exceeded the ADEC cleanup levels. With the exception of these PAH concentrations, each of the sites did not exceed the ADEC cleanup levels in soils for gasoline range organics (GRO), benzene, toluene, ethylben

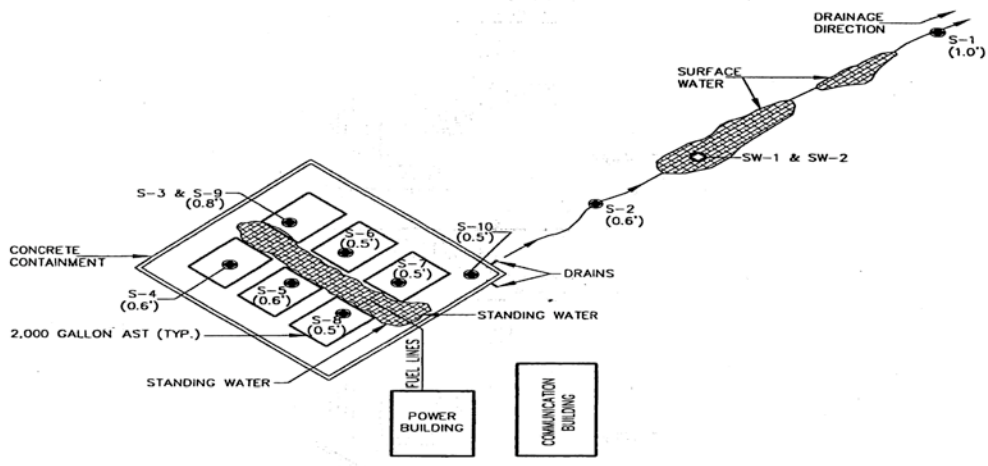
FIGURE 2

Seven soil samples and one duplicate soil sample were obtained from within the fuel containment area and two soil samples were obtained downslope of the containment at this facility as shown in Figure 2. The soil samples were analyzed for the presence of GRO, BTEX, and DRO. Sample S-3 and the duplicate sample, S-9, were also sampled for the presence of PAH compounds. Each of the soil samples and the duplicate sample obtained from within the containment were impacted above the ADEC Method 2 soil cleanup levels for DRO. One of the soil samples collected downslope from the containment area (S-2) also exceeded the DRO cleanup levels. This sample also had slight fuel odors. The soils within the containment area and about 30 feet downslope of the containment area will require remediation to reduce the DRO concentrations below the cleanup level of 230 mg/kg. The laboratory analytical results are summarized on Tables 3, 4, and 5.

The surface water sample and duplicate sample obtained downslope from the containment area did not exceed the ADEC ground water GRO, BTEX, DRO, or PAH cleanup levels.

The impacts at this site appear to be the result of poor fuel handling practices. Surface staining was visible within the containment area and water standing within the containment had a slight sheen which worsened when the soils were disturbed. There was a minor amount of vegetation and bedrock outcrop was prevalent within the containment area. Bedrock was generally encountered within 0.8 feet during the sample collection activities. Soils within the containment were gravely sand with some silt. Soils outside the containment were organic-rich silty sand with some gravel.

Due to the relatively large area of impacted soils and the shallow depth to bedrock at this site, the recommended remedial action is in-situ, surface application, bioremediation. Costs to perform these actions are estimated to be \$350,000.

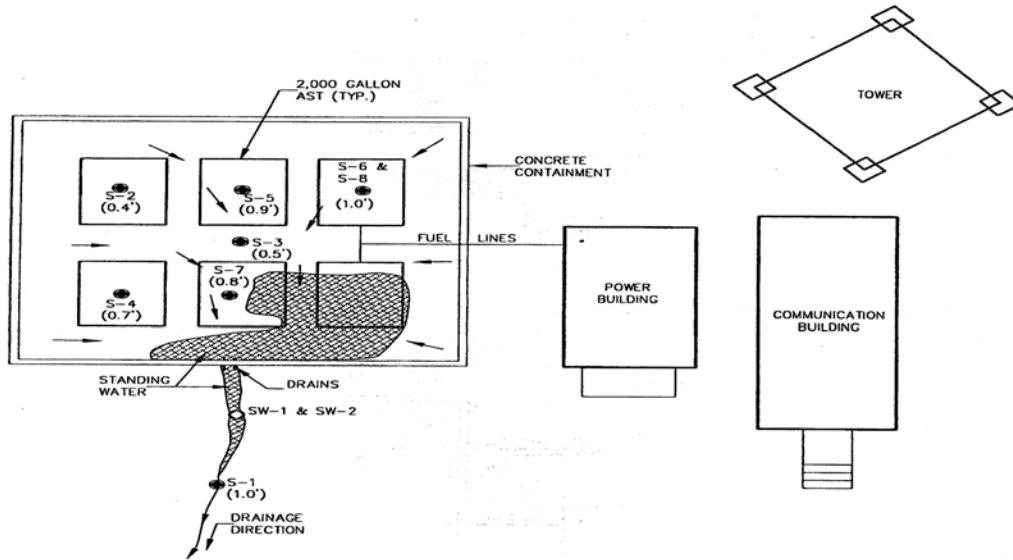
FIGURE 3

Six soil samples and one duplicate soil sample were obtained from within the fuel containment area and one soil sample was obtained downslope of the containment at this facility as shown in Figure 3. The soil samples were analyzed for the presence of GRO, BTEX, and DRO. Sample S-6 and the duplicate sample, S-8, were also sampled for the presence of PAH compounds. Each of the soil samples and the duplicate sample obtained from within the containment were impacted above the ADEC Method 2 soil cleanup levels for DRO. The soil sample collected downslope from the containment area (S-1) also exceeded the DRO cleanup level. However, this sample was primarily peat and the organic material likely interfered with the DRO detection. The laboratory report for this sample noted the hydrocarbon was unknown. No fuel odors were observed in the soil sample upon collection. The soils within the containment area will require remediation to reduce the DRO concentrations below the cleanup level of 230 mg/kg. Confirmation of the DRO concentration downslope may also be performed by additional sampling. The laboratory analytical results are summarized on Tables 6, 7, and 8.

The surface water sample and duplicate sample obtained downslope from the containment area did not exceed the ADEC ground water GRO, BTEX, DRO, or PAH cleanup levels.

The impacts at this site appear to be the result of poor fuel handling practices. Significant surface staining was not visible within the containment. Water standing within the containment did not have a sheen on the surface area, although a slight sheen did develop after disturbing the soils. There was a fair amount of vegetation within the containment area. Some bedrock outcrop was present within the containment area and bedrock was generally encountered within 1 foot during the sample collection activities. Soils within the containment were primarily bedrock fragments with some finer grained sandy matrix with minor amounts of silt. Soils outside the containment were primarily organic-rich peat overlying bedrock.

Due to the relatively large area of impacted soils within the containment and the shallow depth to bedrock at this site, the recommended remedial action is in-situ, surface application bioremediation. Costs to perform these actions are estimated to be \$300,000.
