REPORT ON REMEDIATION ACTIVITIES
AT
10" KWALE/AKRI PIPELINE, AGWE ETITI, DELTA STATE
(2014/LAR/051/181, 2014/LAR/030/103 & 2014/LAR/147/553)

TO
HSE DEPARTMENT
NIGERIA AGIP OIL COMPANY (NAOC)

DOCUMENT CONTROL AND HISTORY

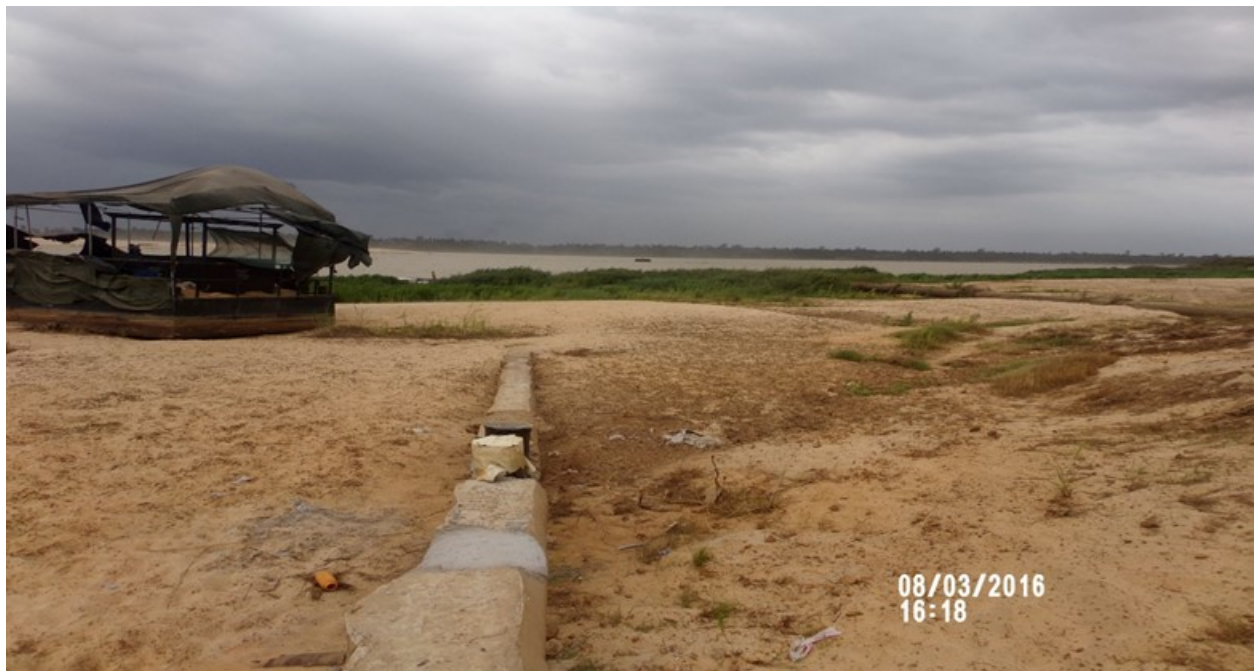
Plate 2.1: Site overview

The site is primarily used for the NAOC ROW and is surrounded by grasses and farmlands. There is a pond on the western part of the spill point. The distance from the site to the nearest human habitation is about 500m with the predominant soil type being sandy soil.

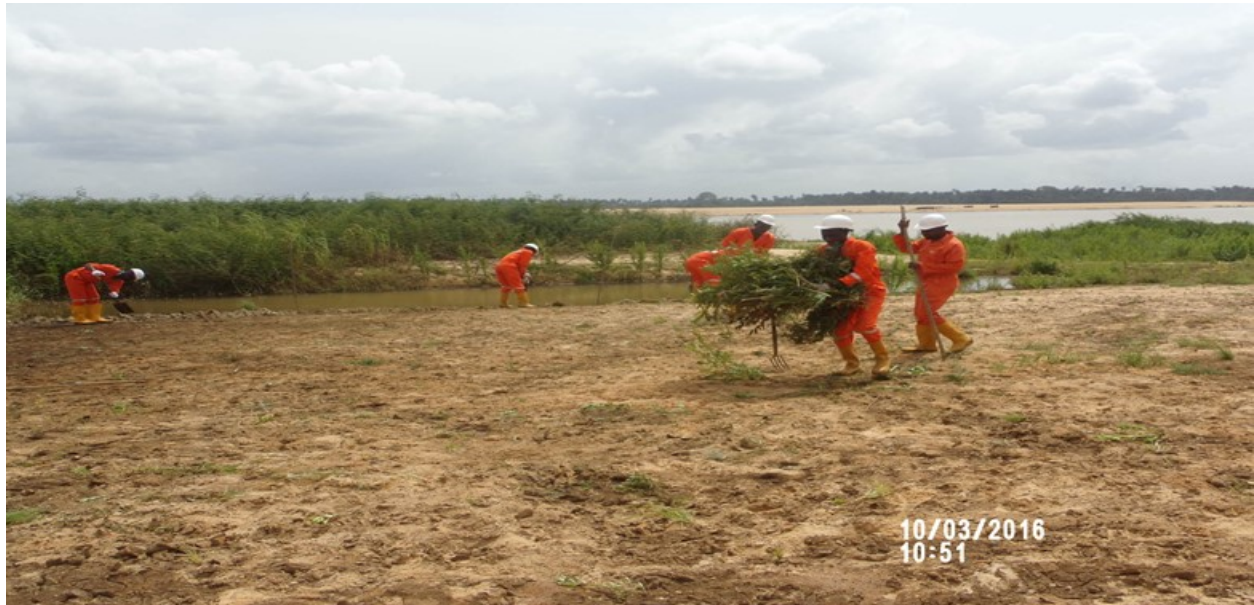
Plate 4.1: Site preparation

The first activity carried out during site preparation was clearing of the site. The site clearing involved cutting down and clearing vegetation and removal of dead logs on the site to facilitate easy movement.

Muster points and caution signs were also set up around the project site for the safety of personnel on site.

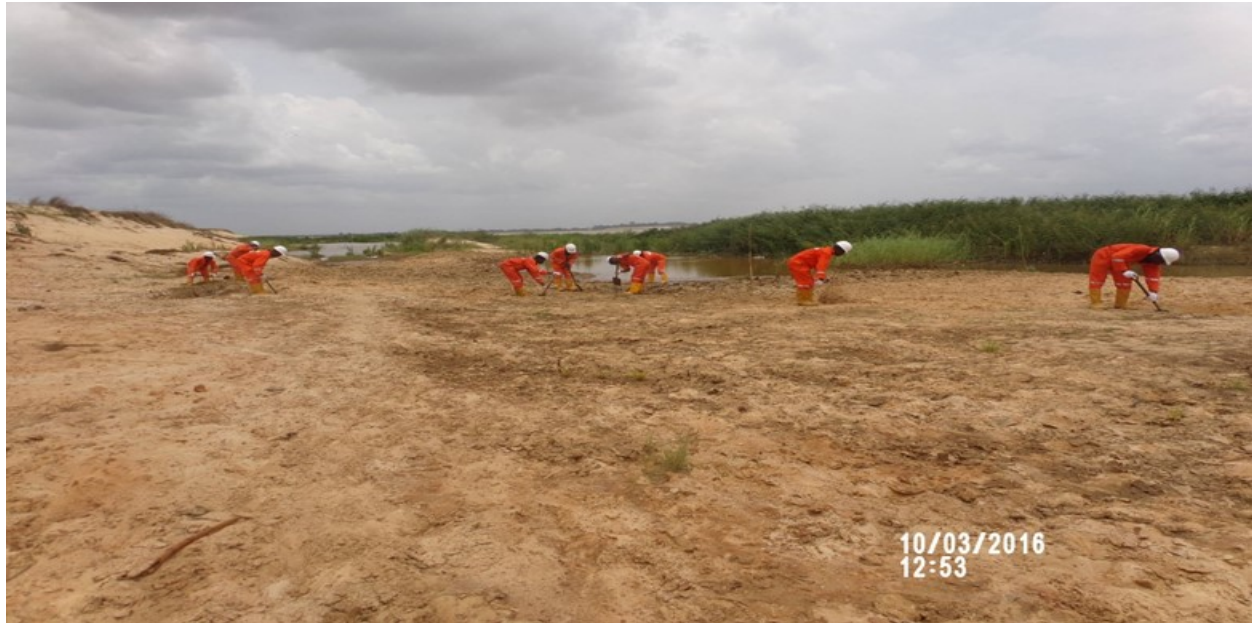
Plate 4.2: Tilling of Impacted soil

After clearing the impacted area, the soil was tilled manually and homogenized with Rakes, Fork shovels and spades. The tilling and Homogenization was carried out to break large clumps of soil into smaller lumps and promote uniform reception of the OSE II Enzyme nutrient additive.

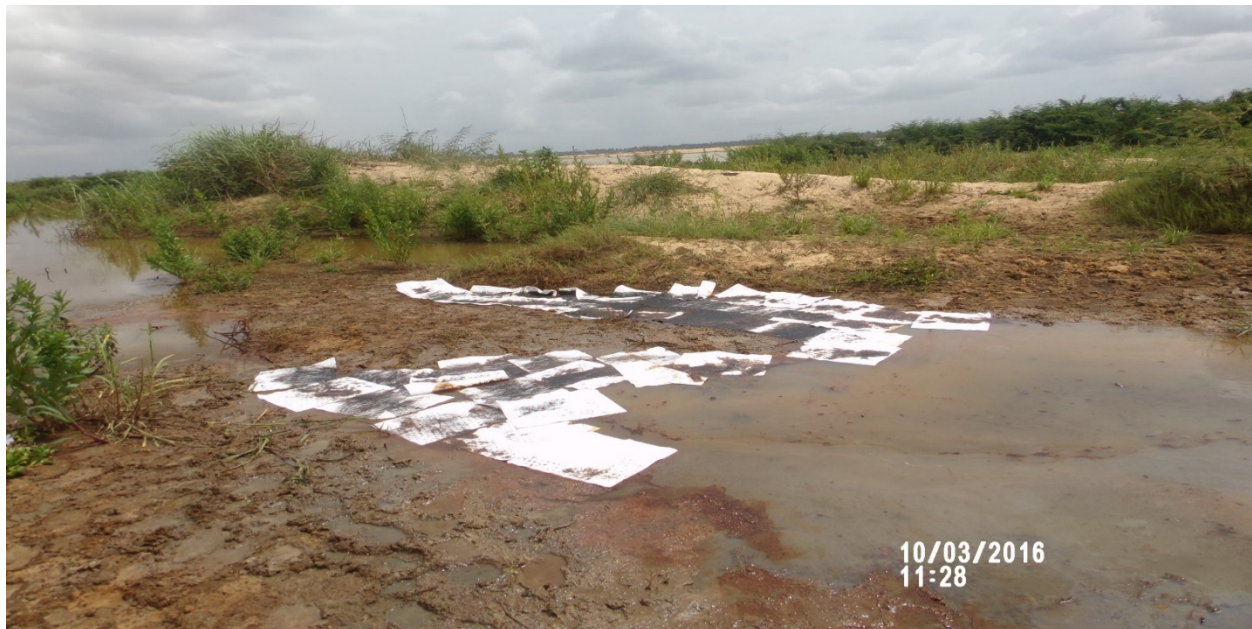
Plate 4.3: Mopping of free phase oil with absorbent pads followed by application of OSE II

Pockets of free phase oil was present on the site which were mopped up using absorbent pads, and followed up with the application of OSE II enzymatic nutrient.

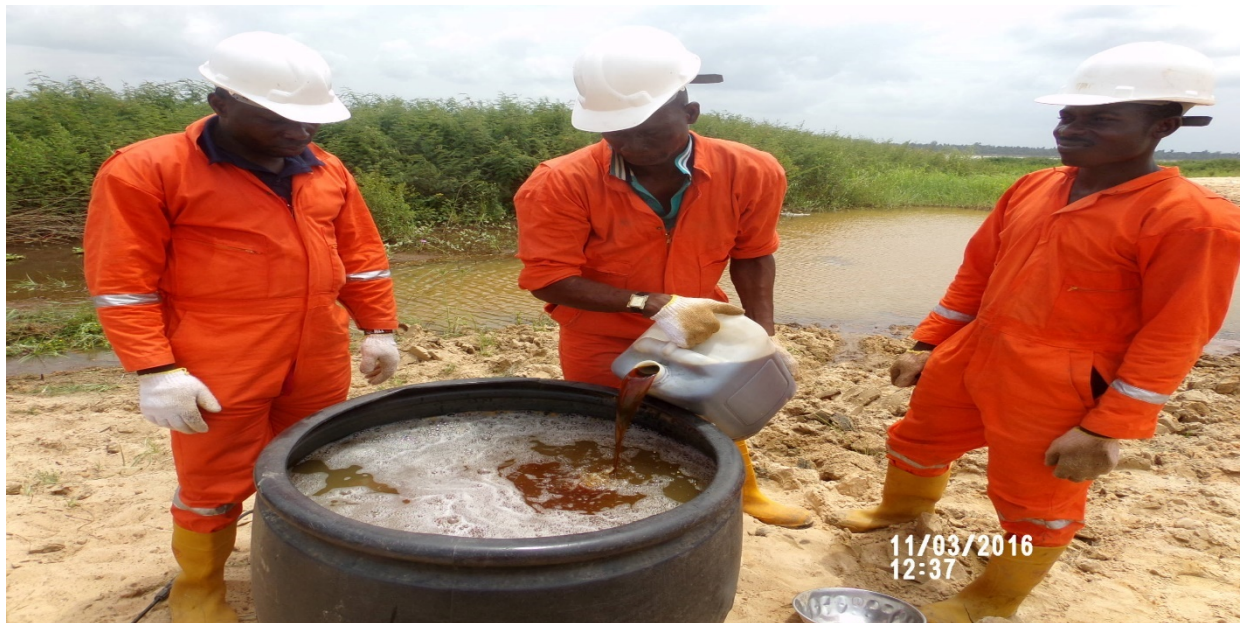
Plate 4.4 Mixing of OSEL concentrate

The Oil Spill Eater 11 (OSE 11) was the nutrient additive used on the project. OSE II was mixed in the right proportion with water from the immediate environment. The

application of the Oil Spill Eater II was carried out after tilling and homogenization with the use of pumps and buckets.

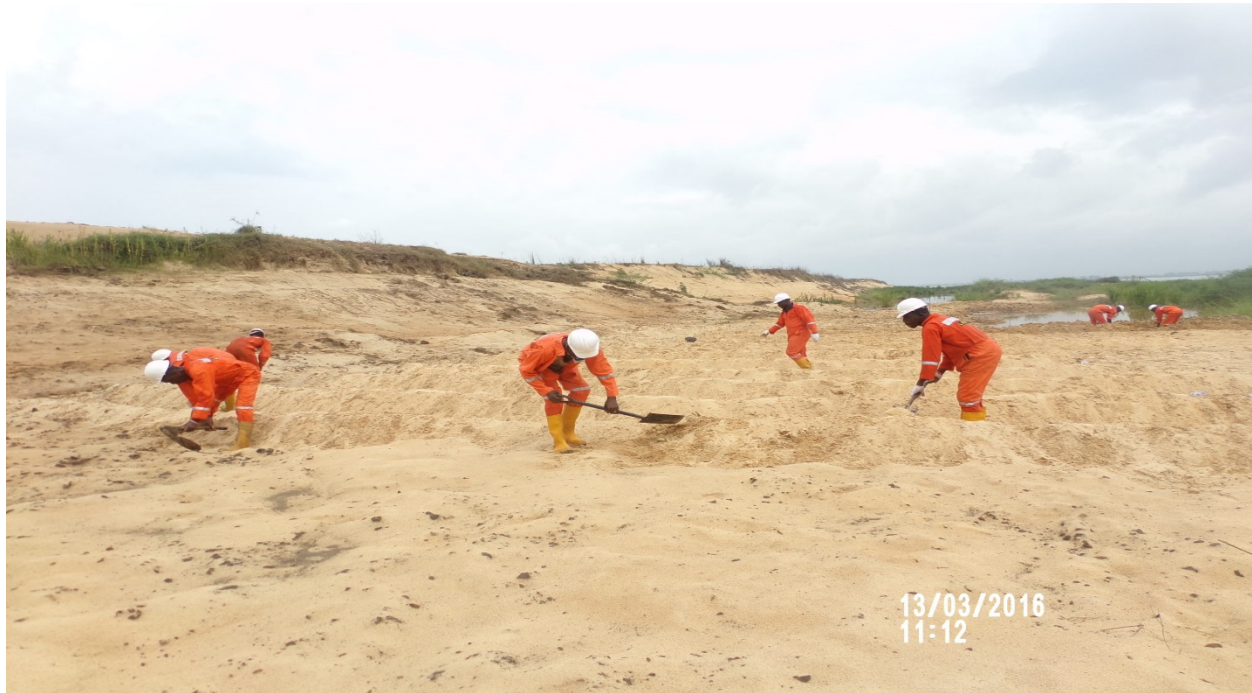
Plate 4.6 Construction of windrows followed by application of OSE II

Windrows were constructed on the entire area mapped for the remediation. Windrows were constructed to aerate contaminated soil below the surface and application of OSE II through biodegradation.

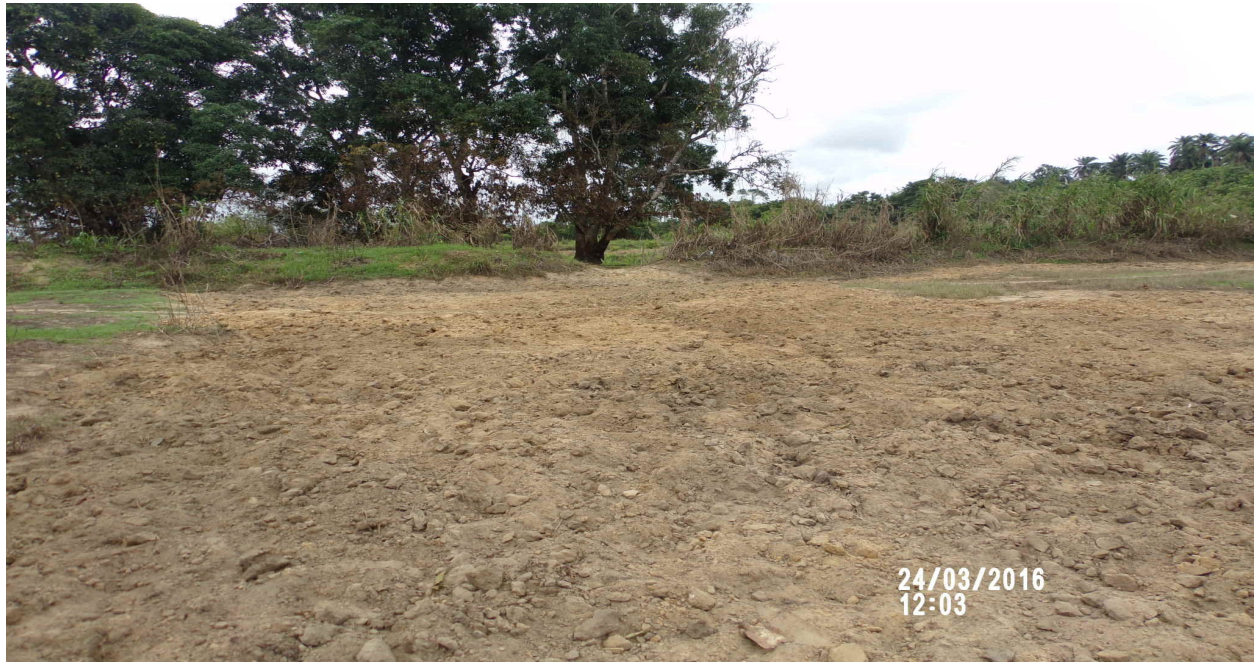
Plate 5.1 Site after Remediation

Post remediation samples were collected after the completion of the remediation project along 10" Kwale/Akri Pipeline by Giolee Global Resources Ltd in line with the project scope of work. The samples were collected to ascertain if TPH levels had been reduced to comply with the relevant regulatory requirements.

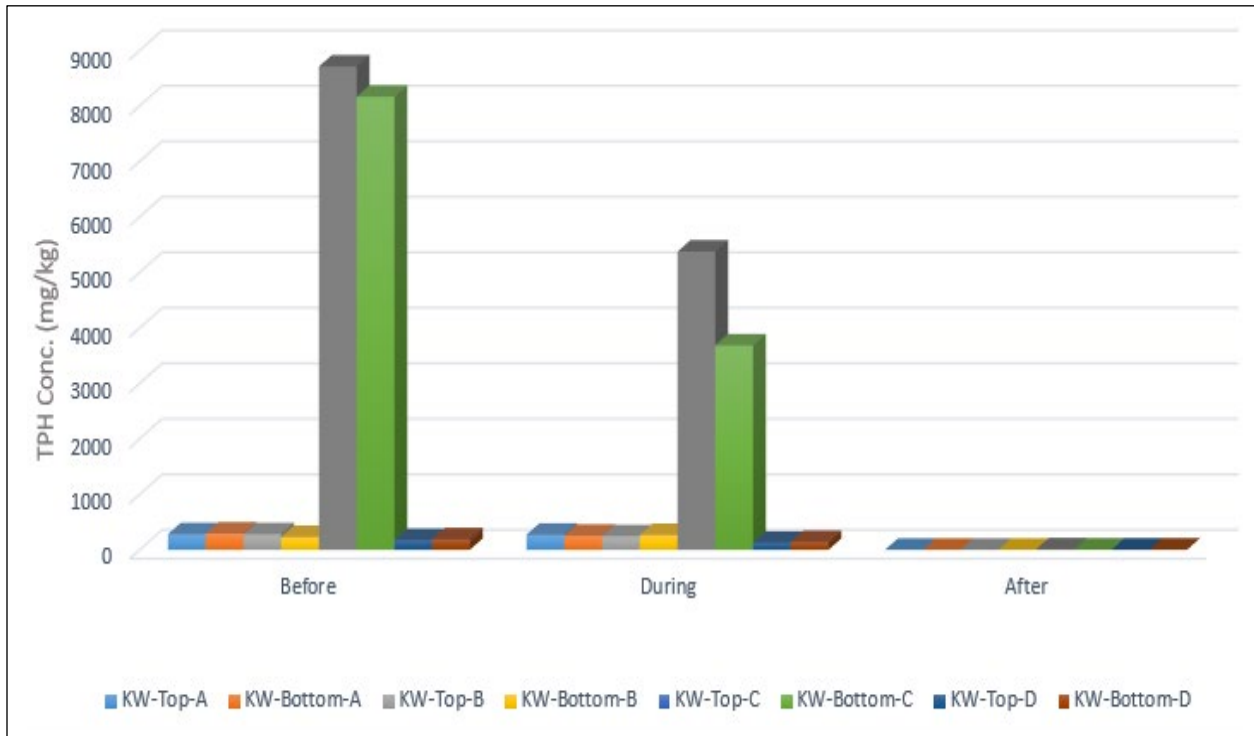
Figure 5.1: TPH concentrations before, during and after remediation

The TPH concentration of all soil samples collected were below 10mg/kg which is indication of the success of the remediation project at the 10" Kwale/Akri Pipeline site.

The graph below shows a visual comparison of the TPH concentration of the samples collected before, during and after remediation

Samples collected before, during and after the remediation project offer further proof of the success of the project. The final TPH concentrations were all less than 10mg/kg which is considerably lower than concentrations of the same samples before the start of remediation and below the DPR intervention value of 5000mg/kg.

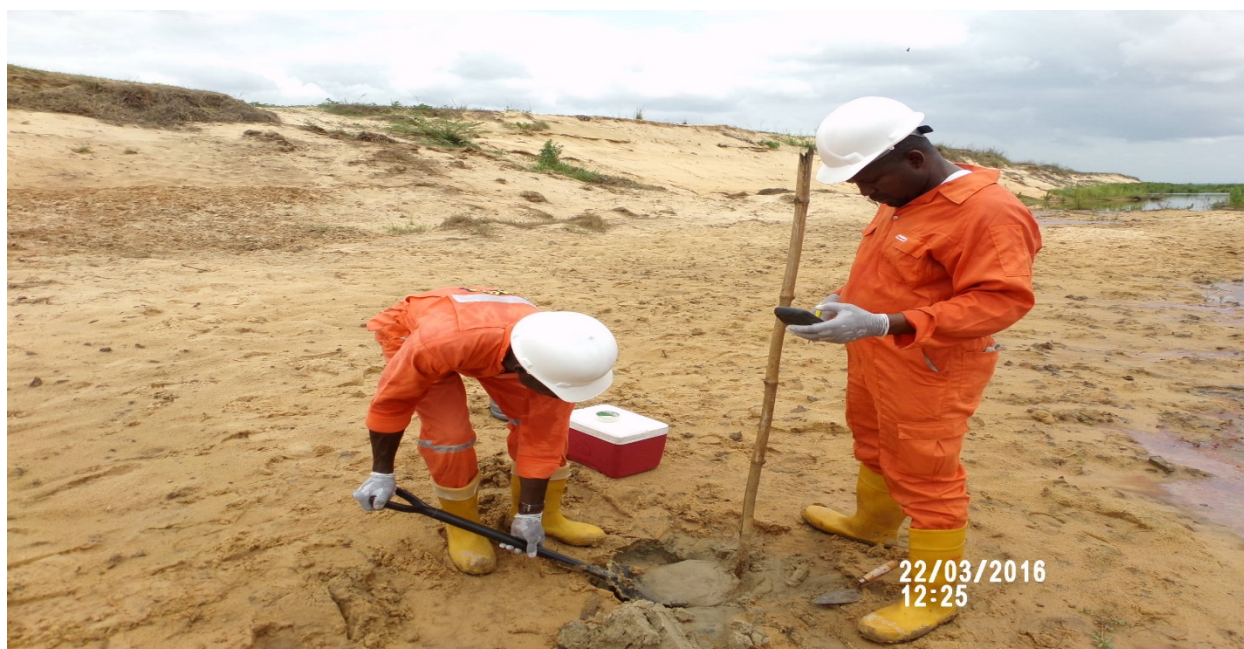
Plate 8: Sample Collection during remediation

Samples were collected before remediation commenced, during remediation and after remediation was completed. Composite soil samples were collected from the range of 0 to 0.3m designated as top and 0.3m to 0.5m designated as bottom.
